Geoff Looney Picture Submission

Geoff Looney is a Menindee local of some 30years. He is a wildlife photographer and an amateur ornithologist. He has published books about local photography and wildlife.

Geoff has documented by images the fish deaths in 2018 and 2023. These are chronologically arranged and the original images are available on request.

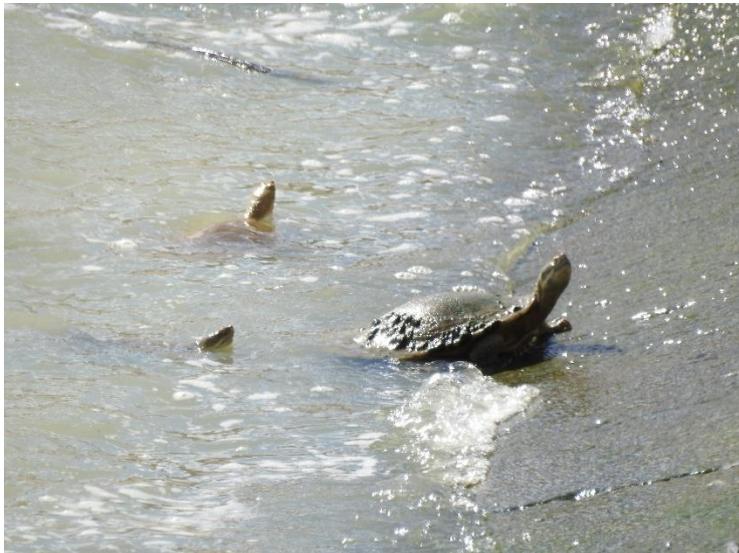
1318 17/11/17

Menindee inlet regulator (2 on map) – turtles trying to escape pool of water. Lakes were full in 2016 and drained by 2017. Why wasn't the water kept? Why was it drained? The water could and should have been left in the lake because there was not the demand downstream for water at that stage. In the past, the water was kept and looking at past reports from the NSW Govt, Broken Hill would have been guaranteed fresh good water for at least 18 months.

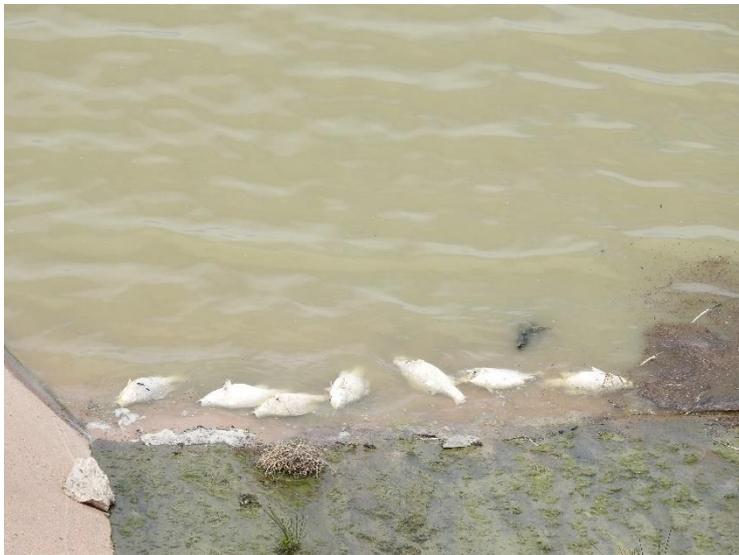
3851 13/1/18

Dead fish Lake Menindee inlet from Pamamaroo (No 2 on map). Note the natural colour of water, but by this stage there was no oxygenated water left in the small pools that remained at the low points of the lake. Note how different the water colour is in the later photos about the 2023 flooding event. There was clearly bad water that came down the river, not natural flood water which in the past “cleaned” the system. The 2023 water polluted the system and killed it.

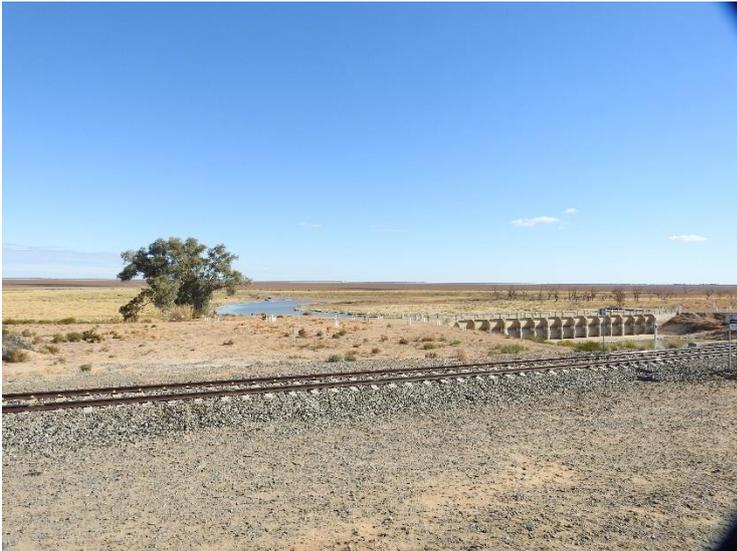
8993 25/6/18

Menindee lookout, viewing lake Menindee inlet regulator figure 2 on map. Illustrative of infrastructure, as revealed in the drought conditions.

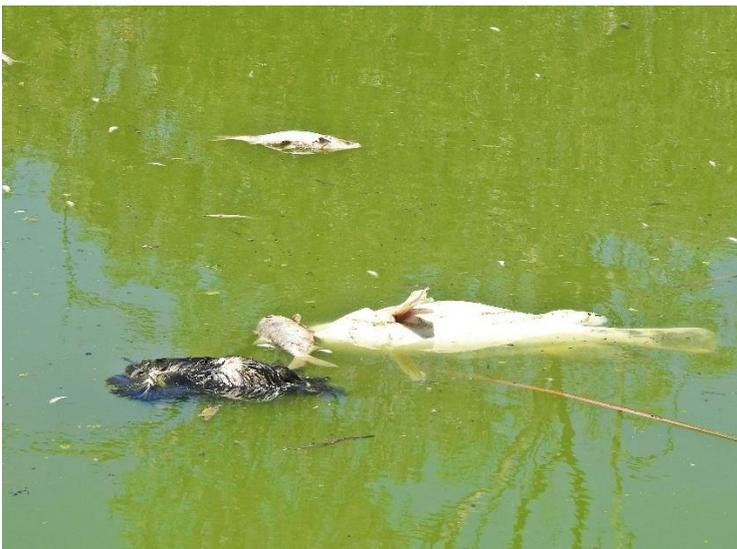
3380 18/12/18

Dead fish incident. Note colour of water – lots of algae. Bird and cod and a bony bream.

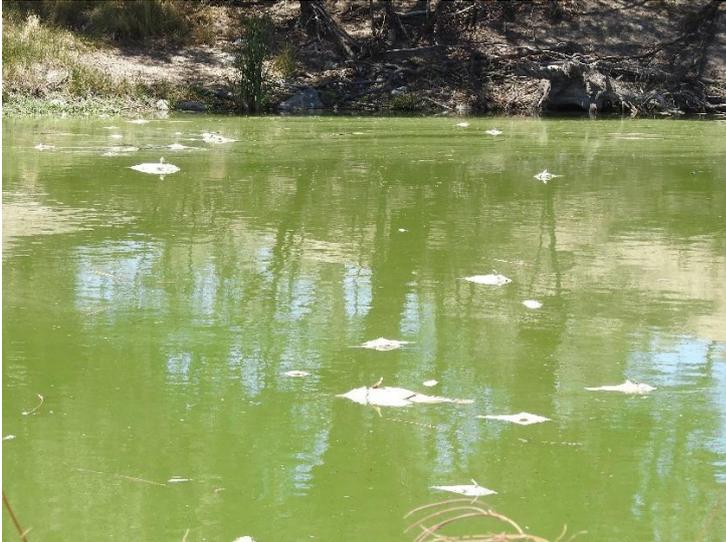
3382 18/12/18

Dead fish incident. Again note the colour of the water – how different from the 2023 incident. Heavy blue green algae.

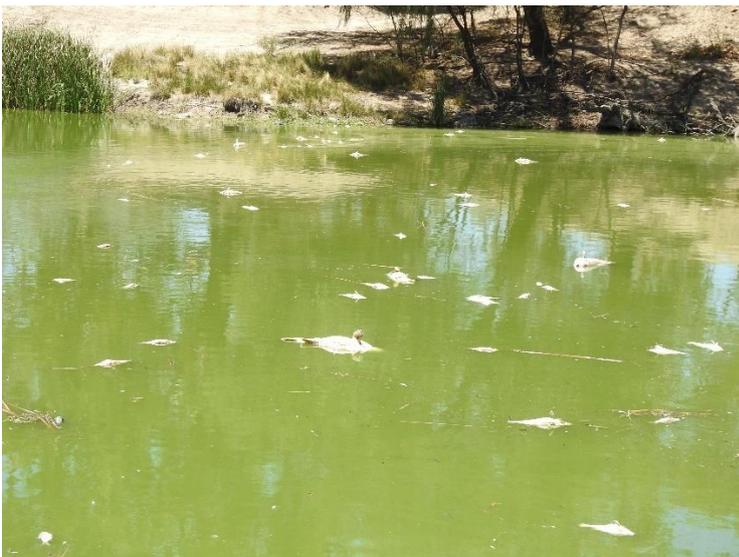
3386 18/12/18 dead fish incident. Again note water.

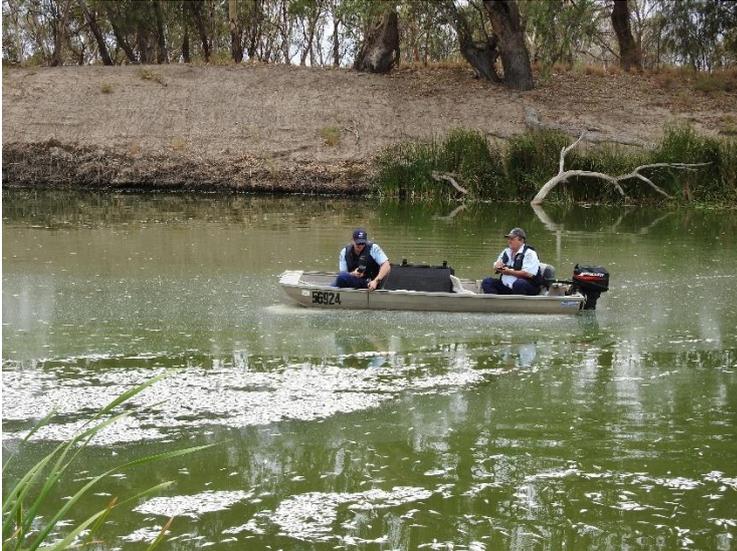
4300 29/1/19

Fisheries NSW measuring oxygen and noting fish deaths.

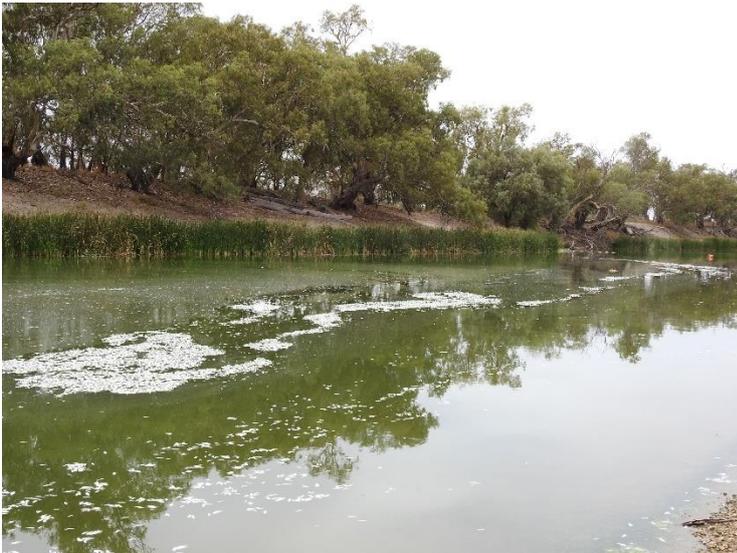
4301 21/1/19 Darling at Menindee Rail bridge from the site of the old town weir. Showing colour of water and extent of fish deaths. Note difference between 2023 riverbank photos with no vegetation on the banks. At this time, during a drought, there is natural vegetation at the river edge. Mr Looney says the 12 month inundation by the flood has cleared the banks.

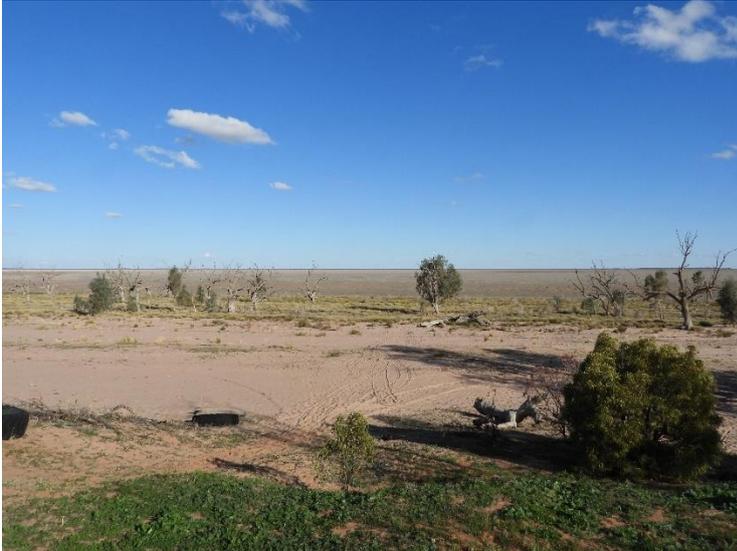
4234 10/6/19

Pamamaroo from the shoreline showing extent of dryness. Typical of the drought conditions.

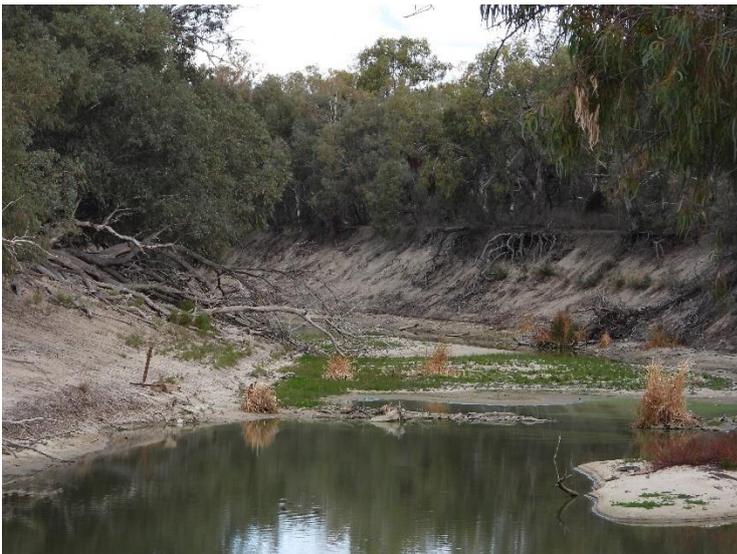
5920 27/7/19

Darling River below weir 32. Illustrating extend of drought effects.

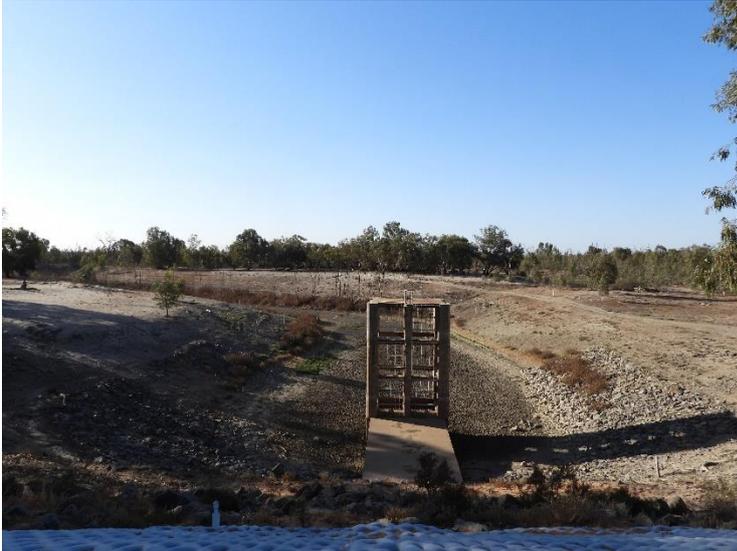
0574 7/11/19

Wetherell outlet regulator (7 on map) – note at bottom of lake. It shows that when the blackwater entered the system from the lakes, the blackwater was at bottom of the lake. “It was a solid wall of black water” According to Mr Looney the lakes were full in 2006, but had been “deliberately drained by 2017, so were already empty when the 2019 drought incident happened. He says that other lakes not on the regulated system (e.g. Lake Speculation and Lake Emu) had plenty of water. “Water NSW has lied about the evaporation rate. It was their drainage rate”

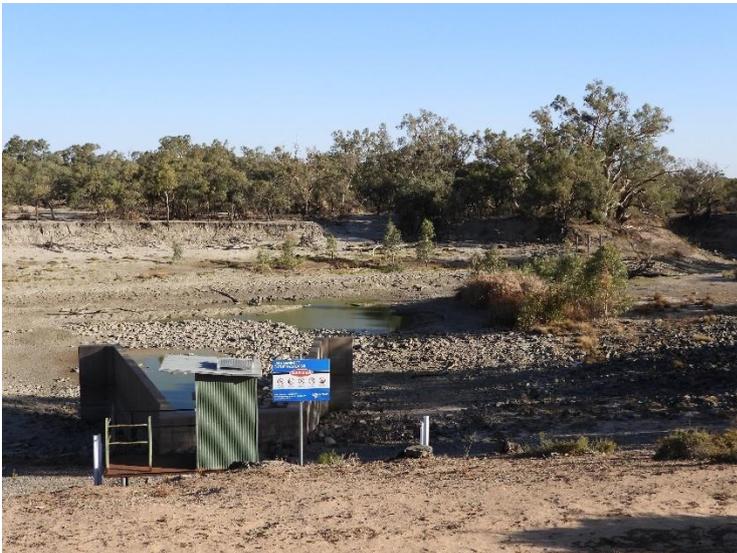
0580 7/11/19

Menindee outlet regulator (3 on map).

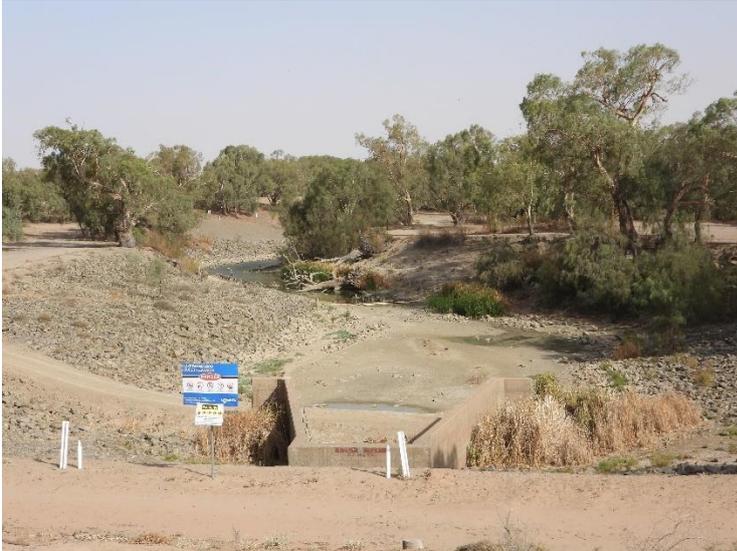
2630 5/1/20

Pamamaroo Outlet regulator. Showing effects of the “intentional draining”. Therefore no water to assist during the flood. At this time, all the fish were below weir 32 because there was no water about that point.

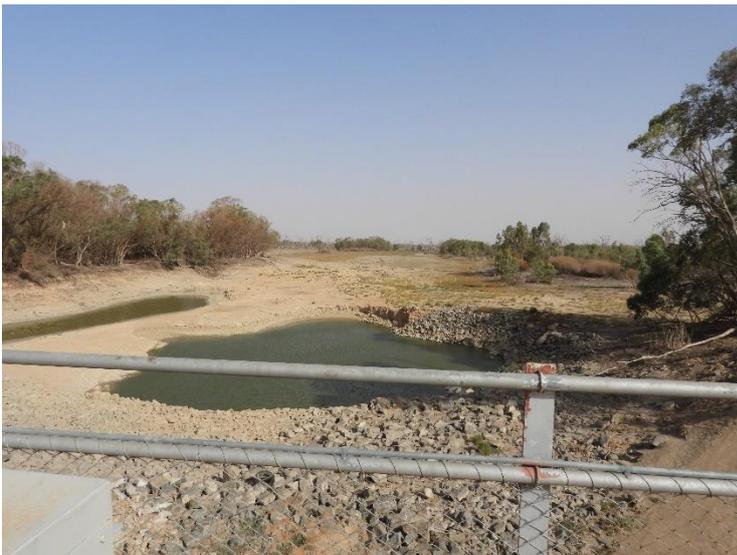
2634 5/1/20

Looking into Lake Wetherell from Pamamaroo, showing outlet from Wetherell into Pamamaroo.

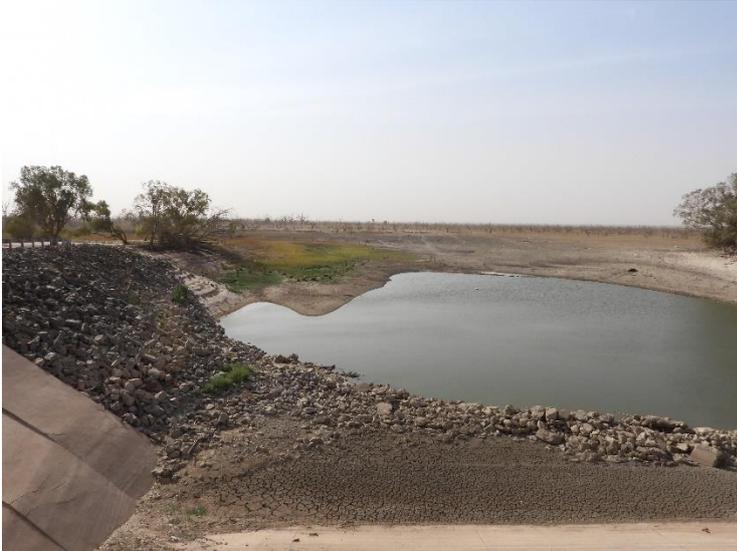
2640 5/1/20

Inlet regulator into Pamamaroo from Wetherell

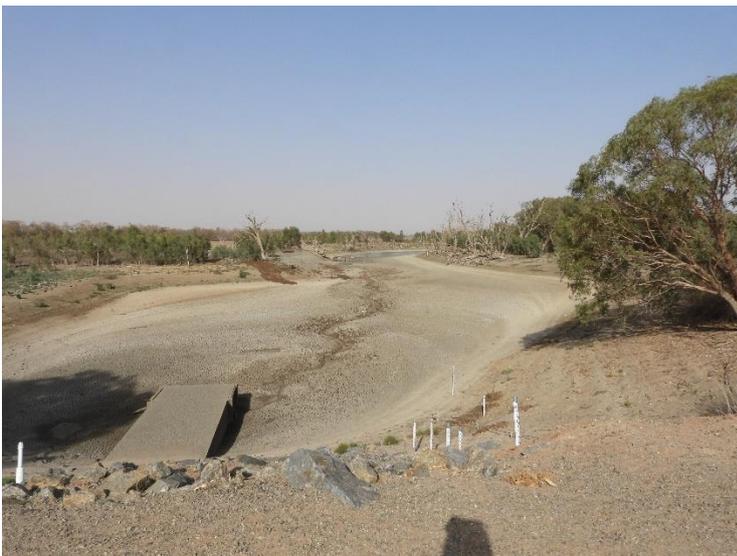
2662 5/1/20

Outlet from Wetherell into darling river, looking into Wetherell. Note depth of regulator - therefore blackwater released 2023 was at the bottom of the lake.

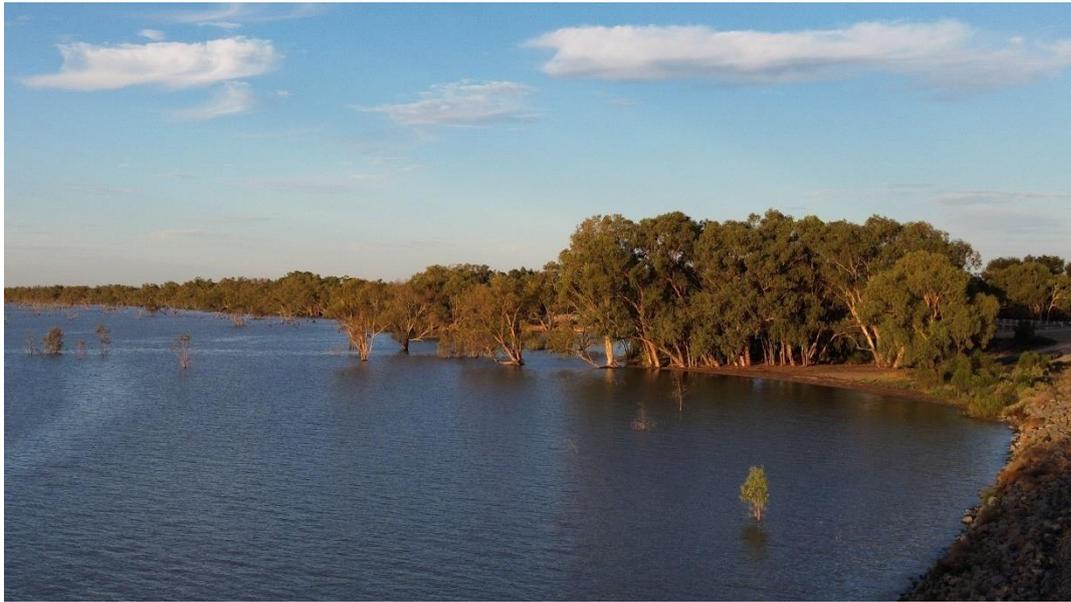
0003 20/1/23 Lake Pamamaroo inlet regulator (5 on map) showing darkness of water that came in (blackwater). This photo has been adjusted to make it lighter. My Looney says the water was “as black as pitch”

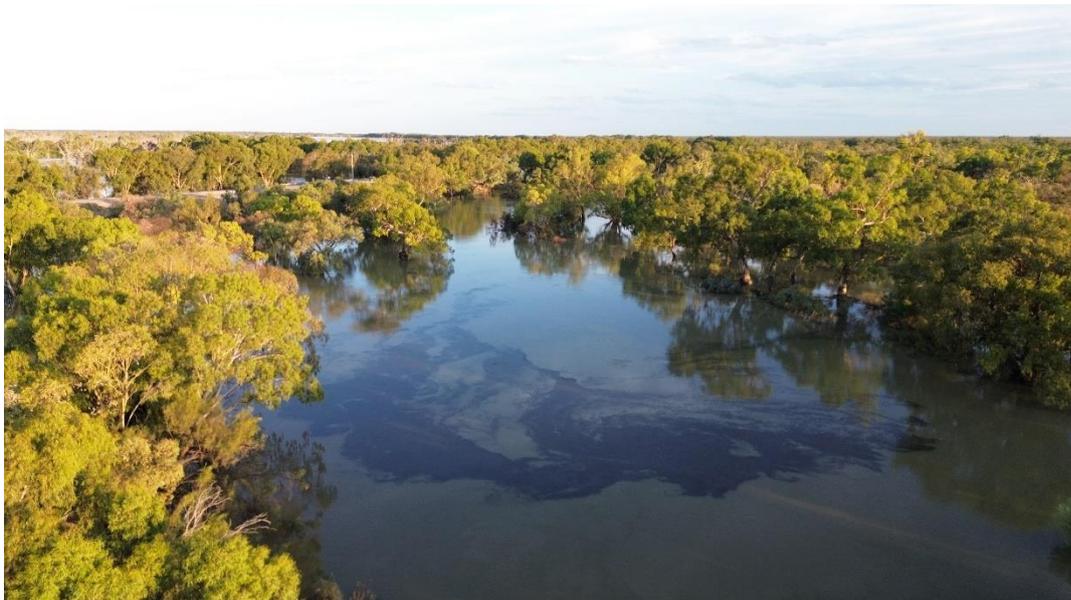
0030 23/1/23 Drone shot of Pamamaroo outlet regulator (6 on map) showing black water coming into river and not mixing.

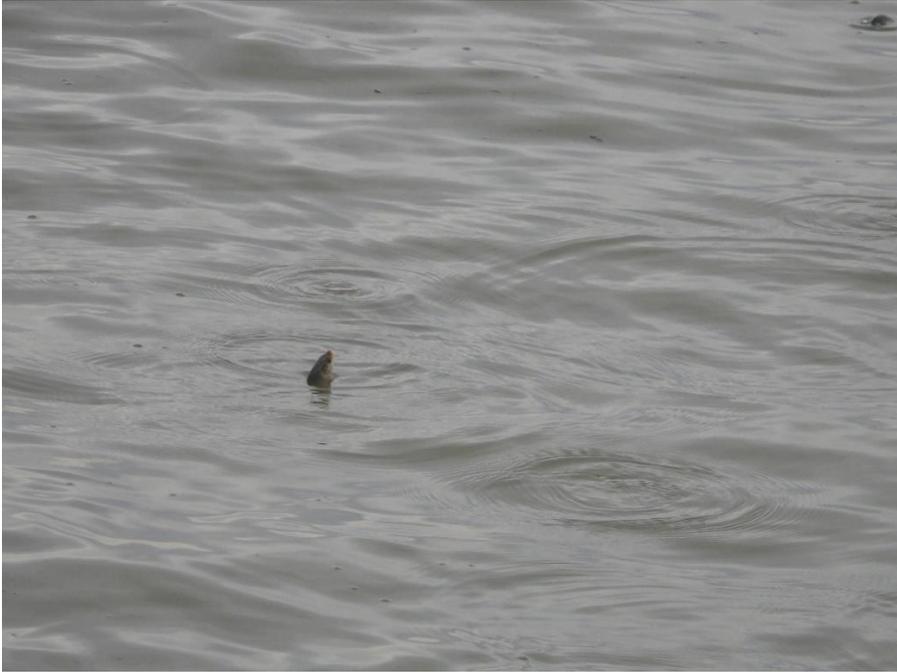
0801 8/1/23

Fish jumping out of Pamamaroo to get air. Lake bubbling as carp jumped to get oxygen. Illustrating that water was already severely deoxygenated. This was happening across the lake and river system at Menindee.

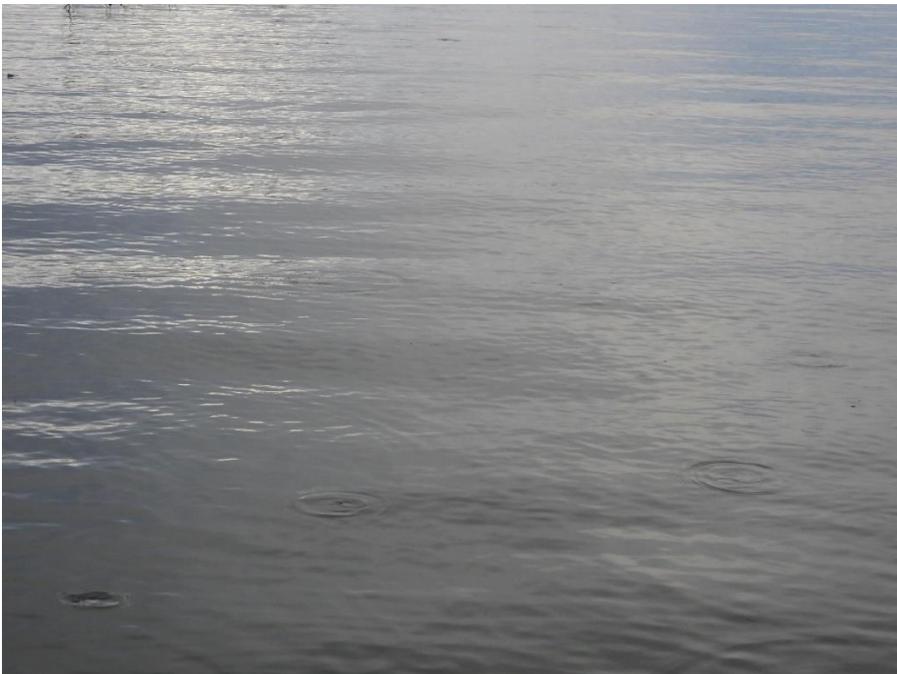
0812 8/1/23 Pamamaroo – carp seeking oxygen.

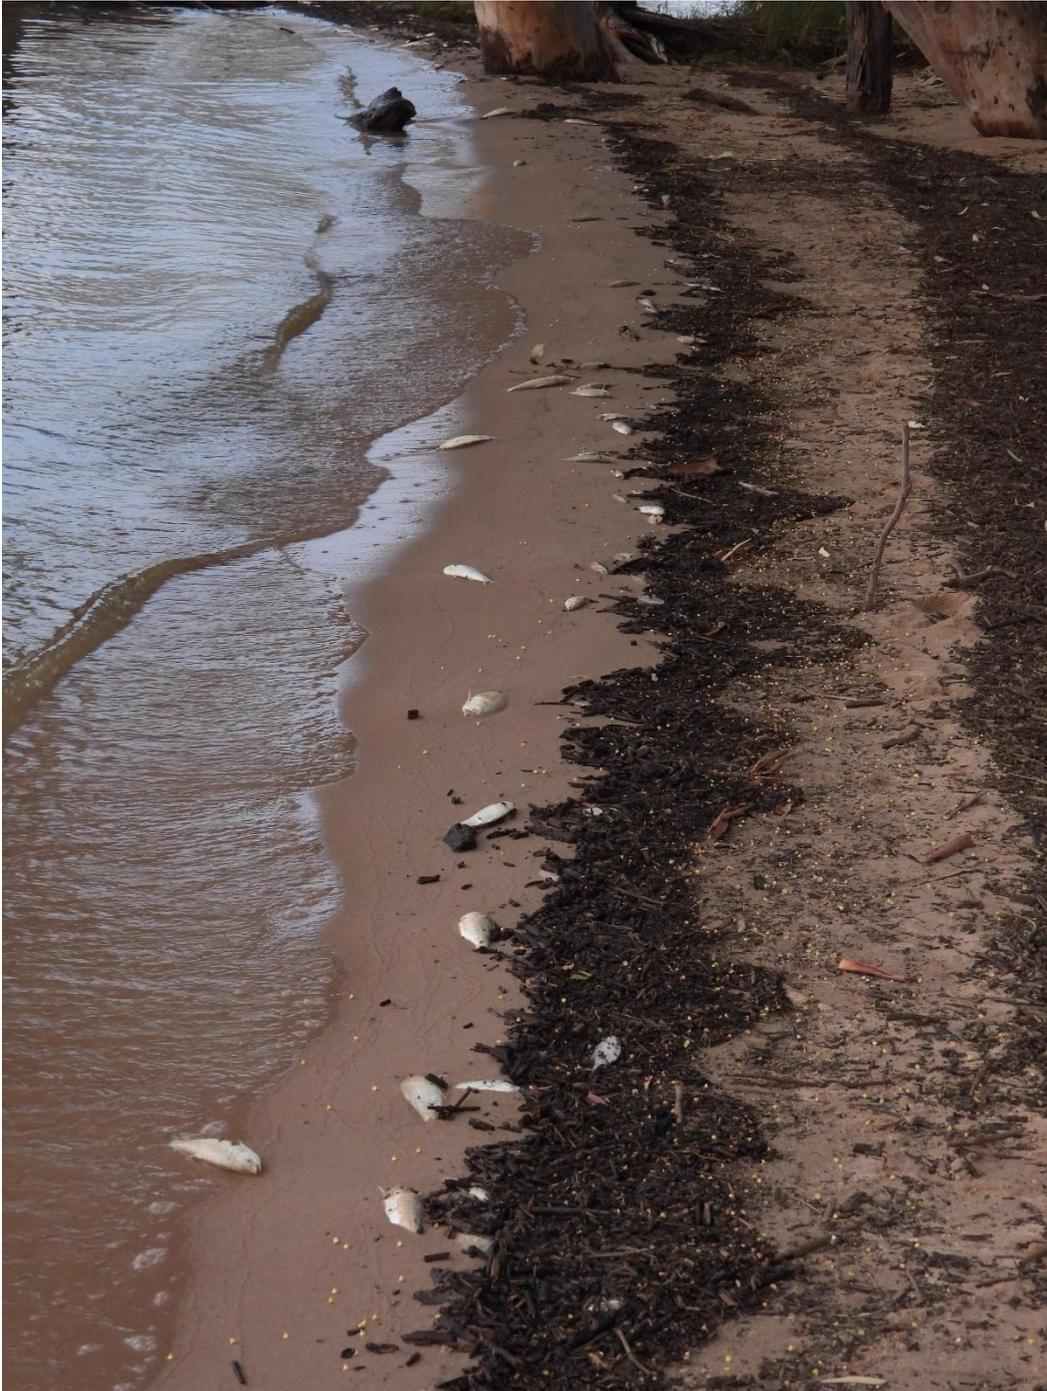
0815 8/1/23 Pamamaroo foreshore fish deaths.

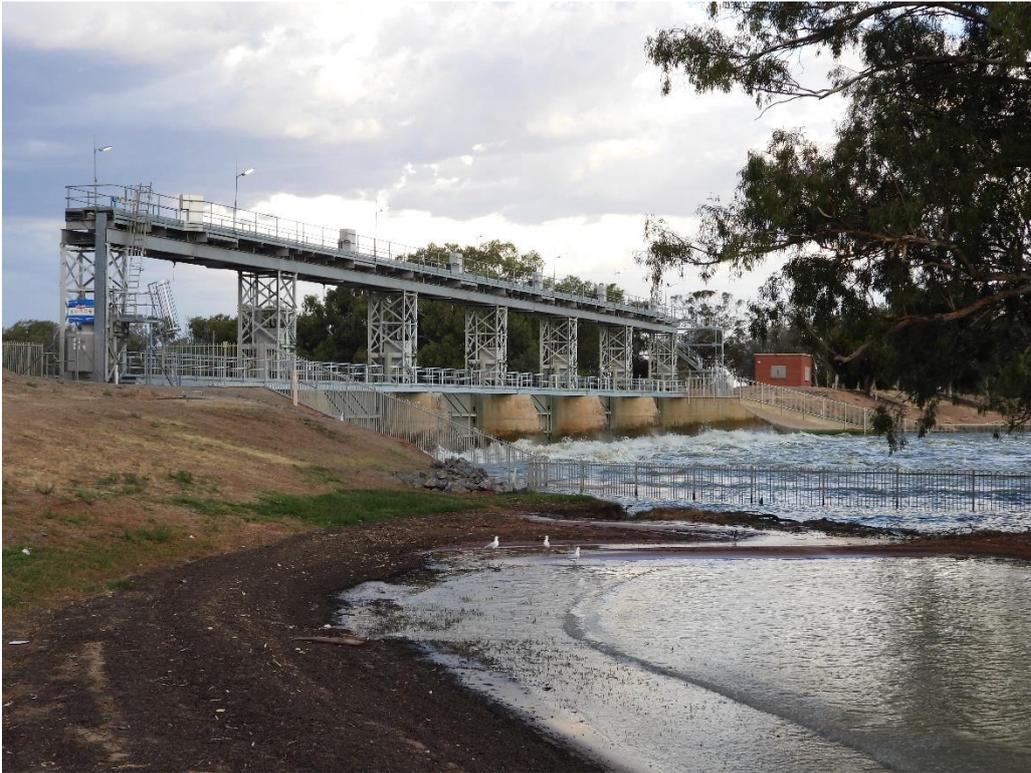
1027 16/1/23

Main weir's last full flow before the feb/march fish deaths. At this time the fish were not biting – do not know why there was no response to fishing lures. What normally happens is that the peak is allowed to go into the lakes and this brings the blackwater into the shore and it cleans. This did not happen. They should have done the same as happened in 76 90s and 2011. Because the lakes were so low, the regime was changed and the blackwater was not cleaned.

“Previously the peak would come so high it was over the tops of the gates and it would be allowed to clean the lakes and it was allowed to do this. They don't do this now.”

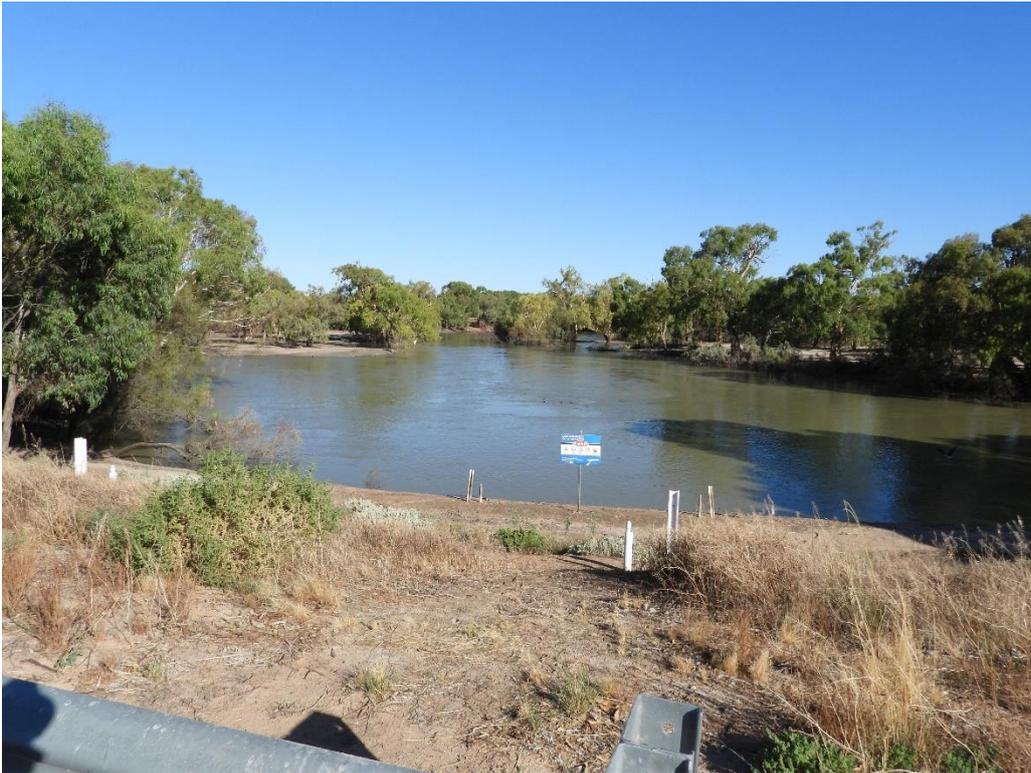
1831 6/2/23

Pamamaroo outlet regulator at flood level. Note darkness of water.

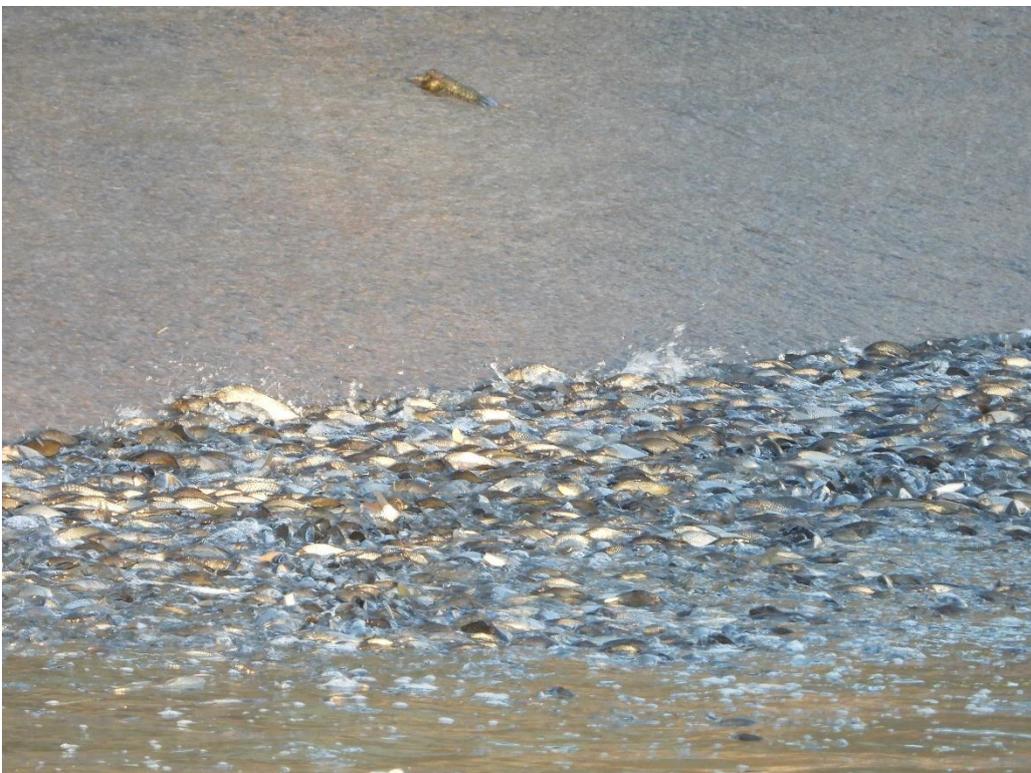
2380 18/2/23

Main weir Menindee fish deaths. Fish struggling and dying. Yabbies trying to escape. Fish trying to get upstream.

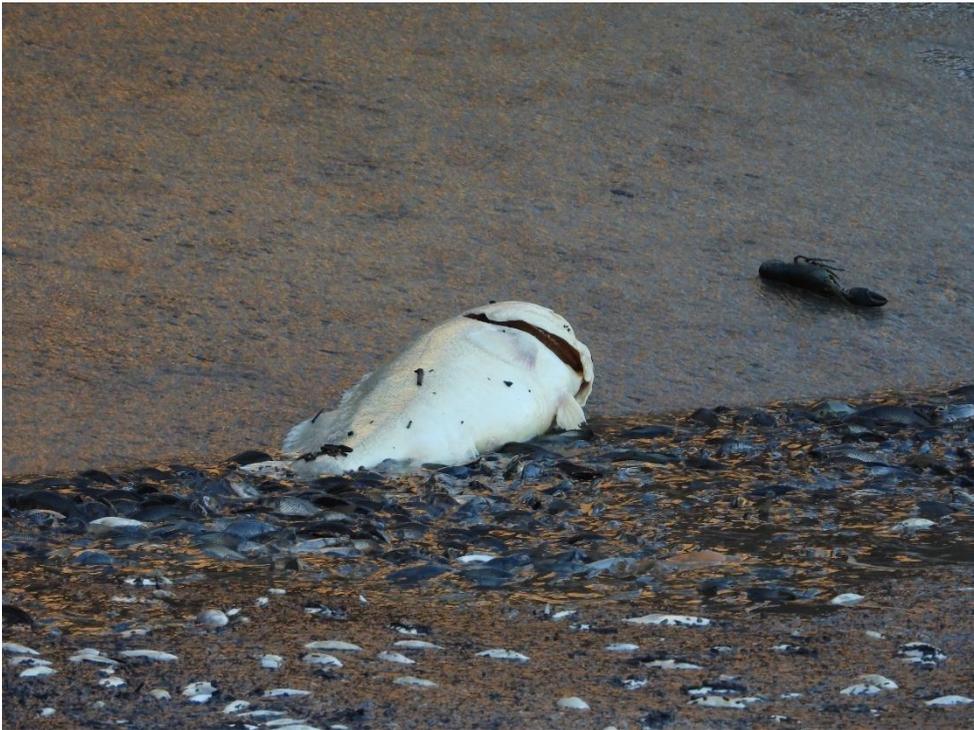
2383 18/2/23

Main weir Menindee. Dead cod and yabby that tried to escape. Carp and bony bream.

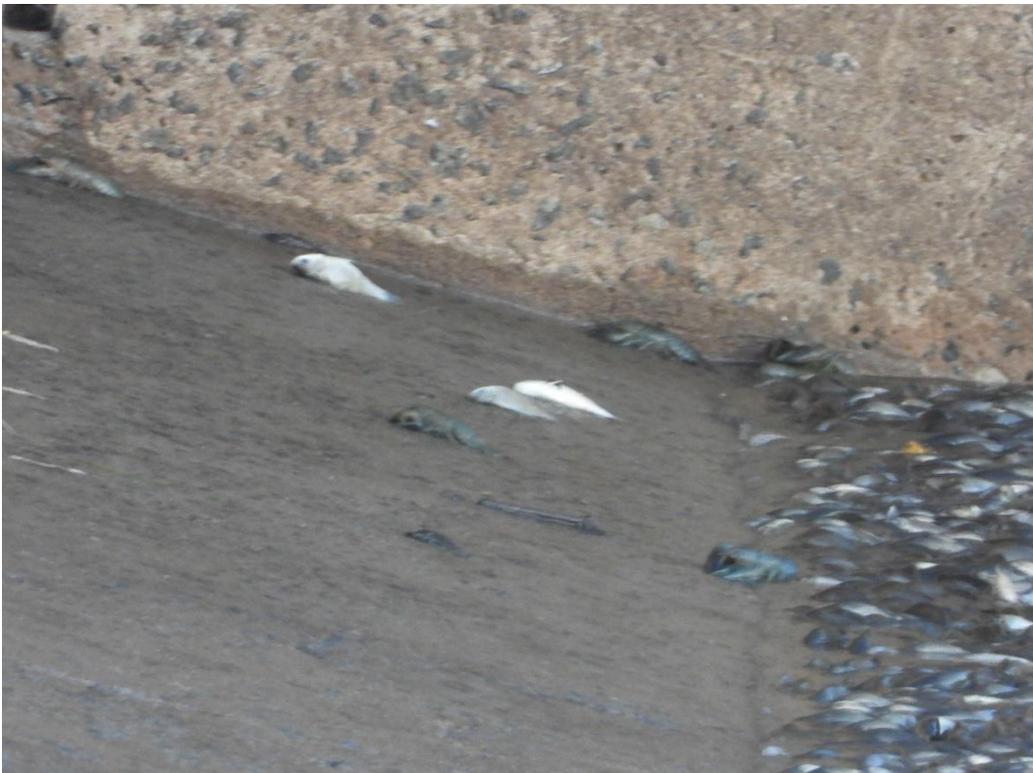
2389 18/2/23

Main Weir Menindee. Dead native fish and yabbies trying to escape up the weir apron. Locals harvested buckets of yabbies.

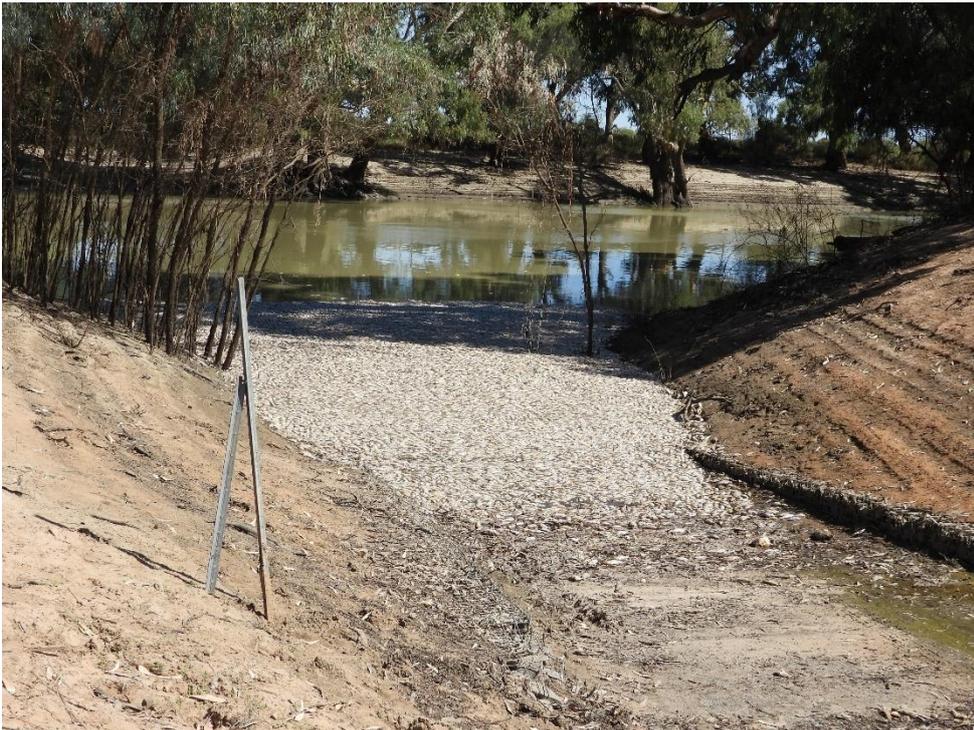
2770 27/2/23

One week later, showing dead fish at Menindee boat ramp. Fish were mainly bony bream.

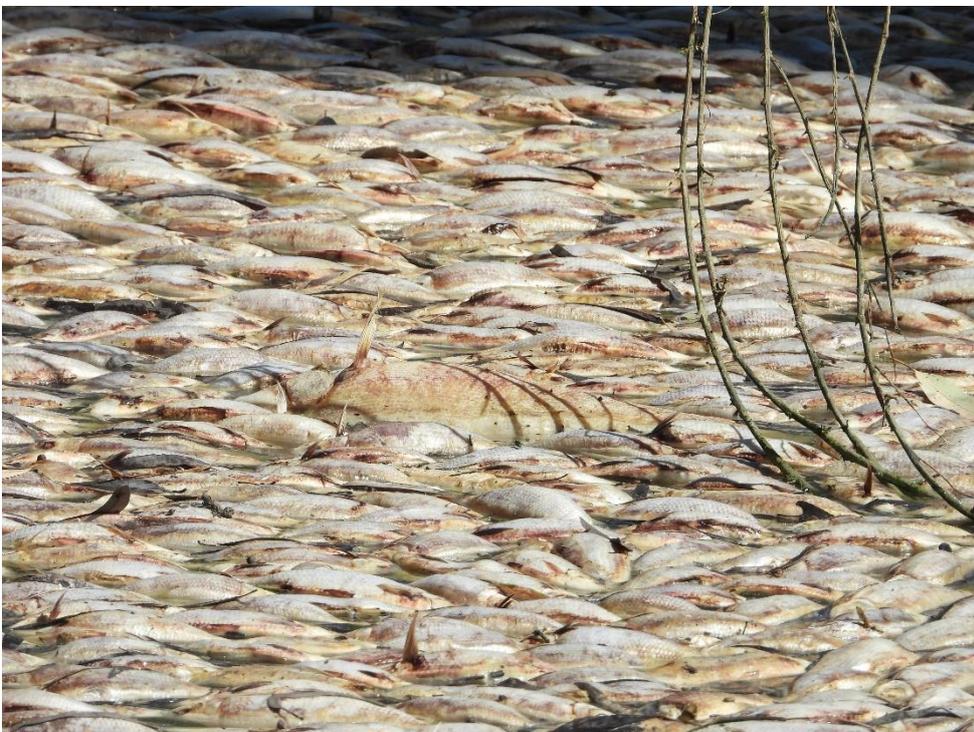
2772 27/2/23

Menindee boat ramp close up of dead fish. One perch or cod and lots of bony bream. "I could not stay to take too many photos due to the stench. I was vomiting."

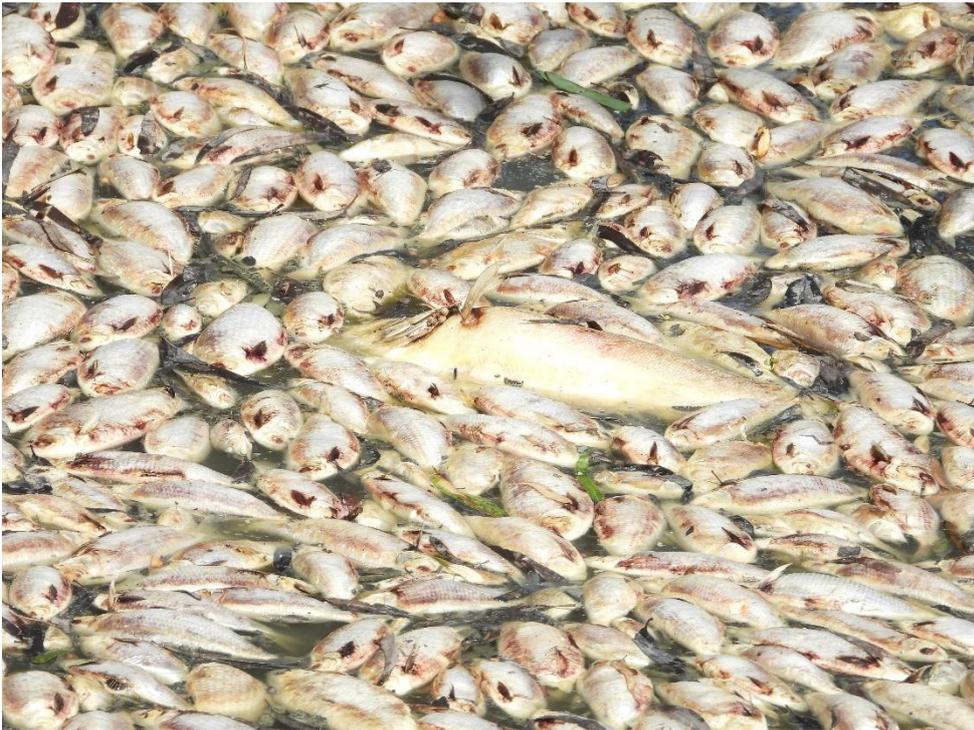
2774 27/2/23

Menindee boat ramp close up of dead fish. One perch or cod and lots of bony bream. Could not stay to take too many photos due to the stench.

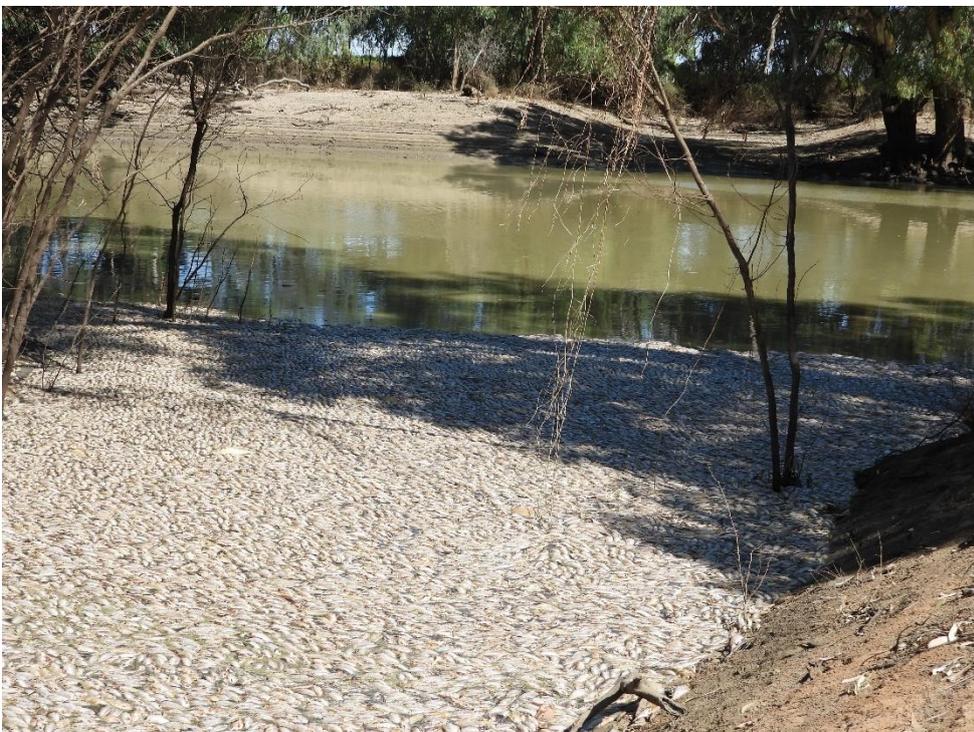
2784 27/2/23

Menindee boat ramp close up of dead fish. One perch or cod and lots of bony bream. Could not stay to take too many photos due to the stench.

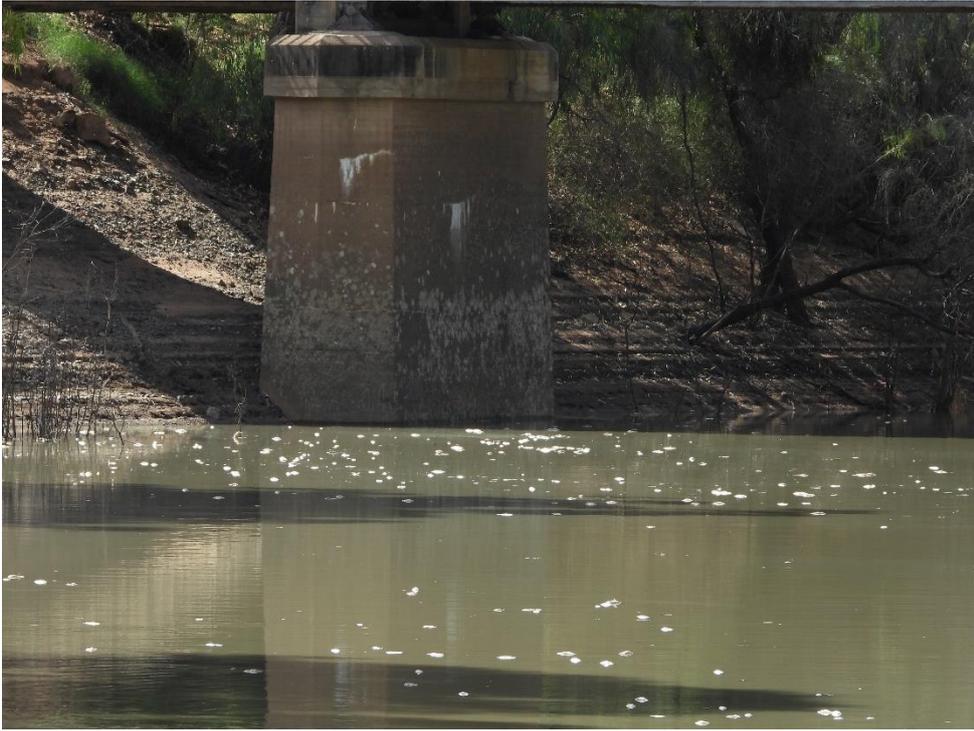
2815 28/2/23

Under Menindee rail bridge. Note water colour.

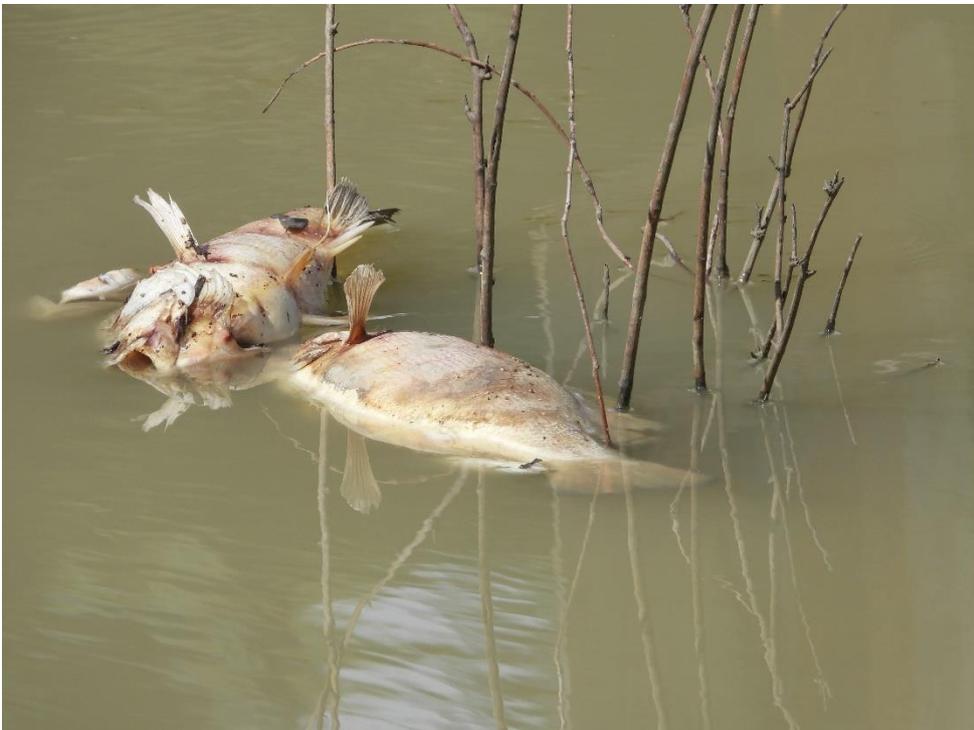
2821 28/2/23

Under Menindee rail bridge. Note water colour. Golden Perch.

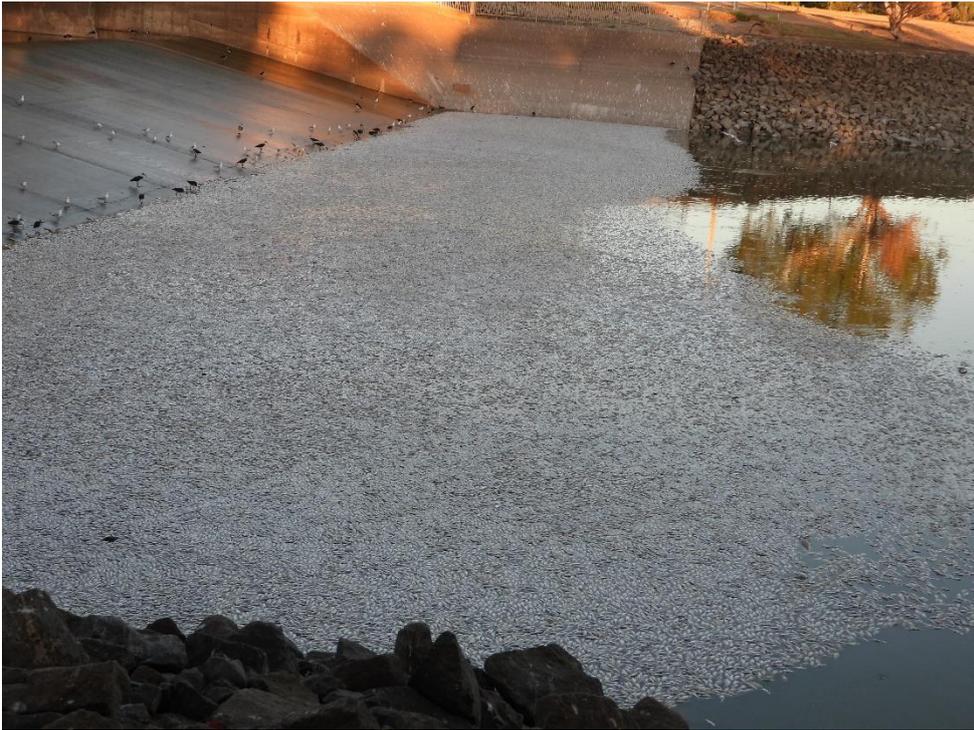
4218 16/3/23

Main Weir apron. Mostly bony bream. Note Ibis had arrived. They were the only ones to be taking fish. Could not understand why there were no more birds gorging on the fish ... had expected that the river would be covered in flocks of birds such as cormorants and pelicans eating all the dead fish. Do the birds know something we don't?

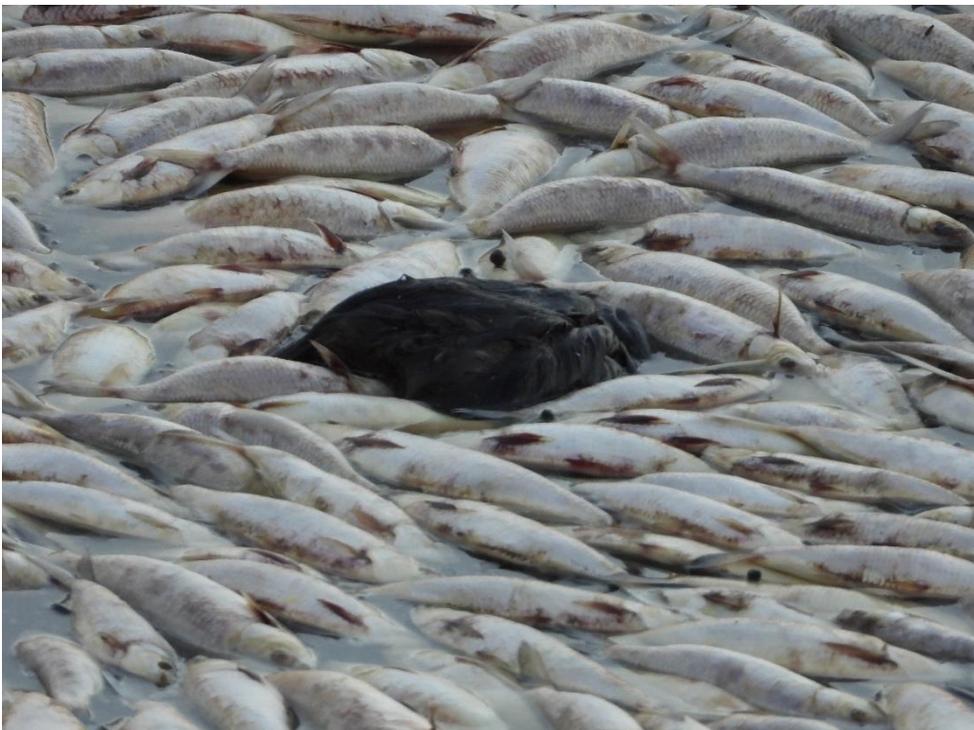
4222 16/3/23

Main Weir apron. Dead swan amongst the fish. Fish are mainly bony bream.

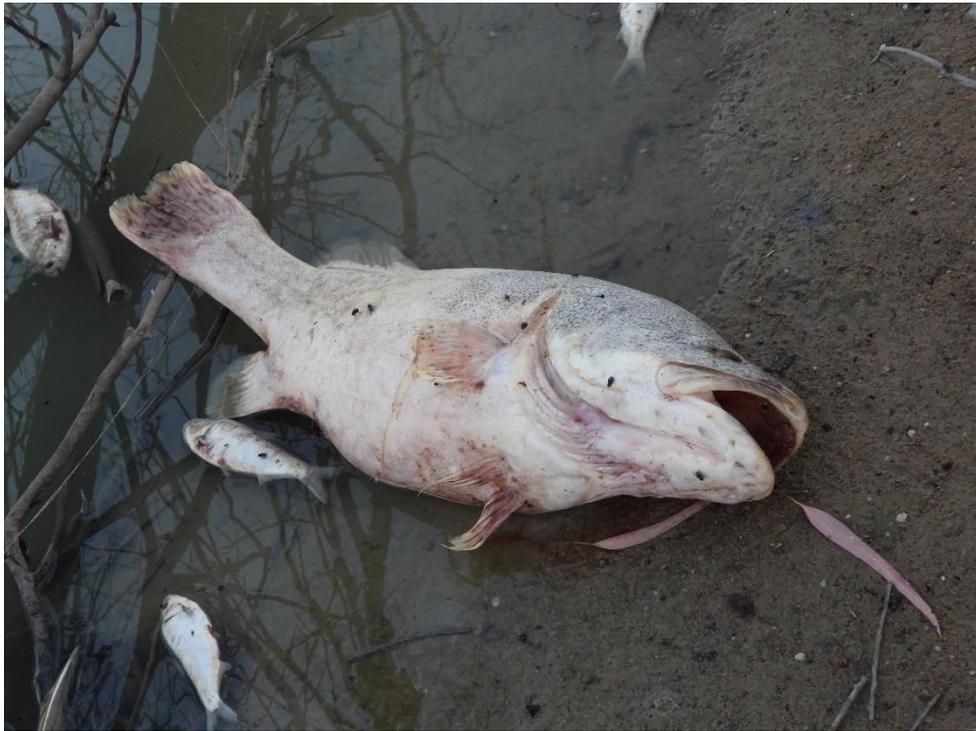
4235 16/3/23 Main Weir. Dead cod and bony bream.
