Geoff Looney Picture Submission

Geoff Looney is a Menindee local of some 30years. He is a wildlife photographer and an amateur ornithologist. He has published books about local photography and wildlife.

Geoff has documented by images the fish deaths in 2018 and 2023. These are chronologically arranged and the original images are available on request.

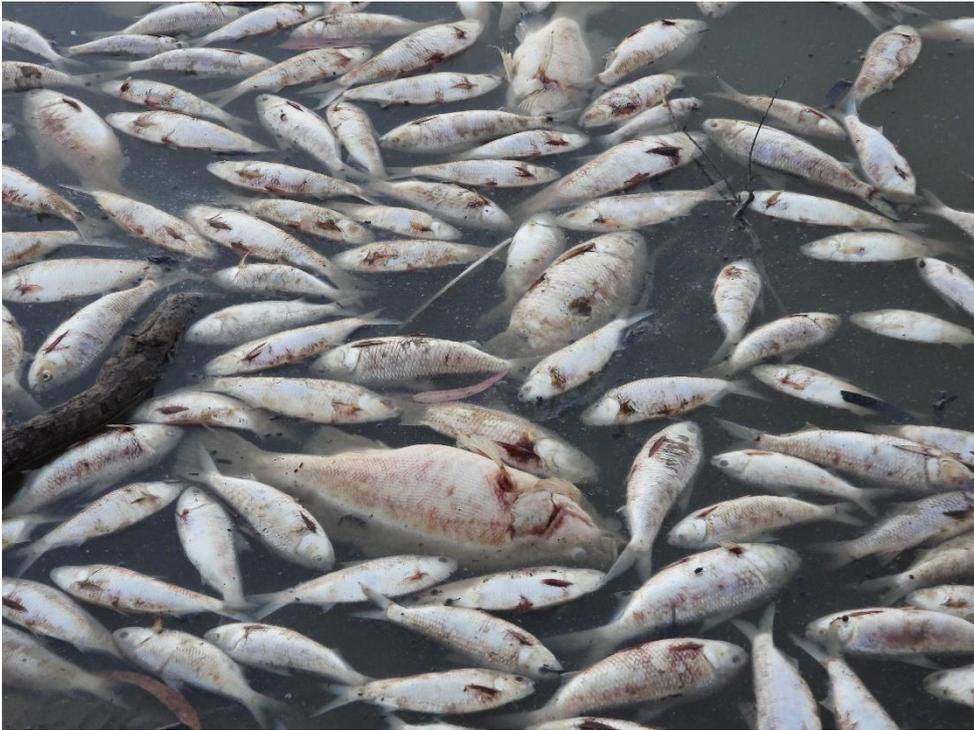
4239 6/3/23 Main Weir - dead fish

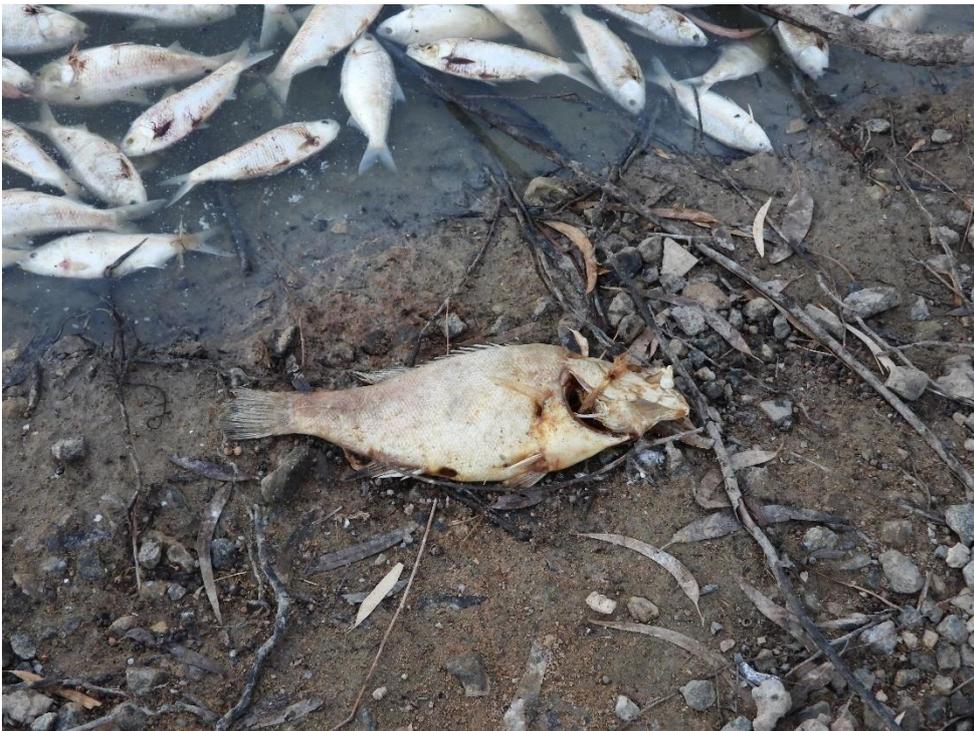
4242 16/3/23 Main Weir - dead fish

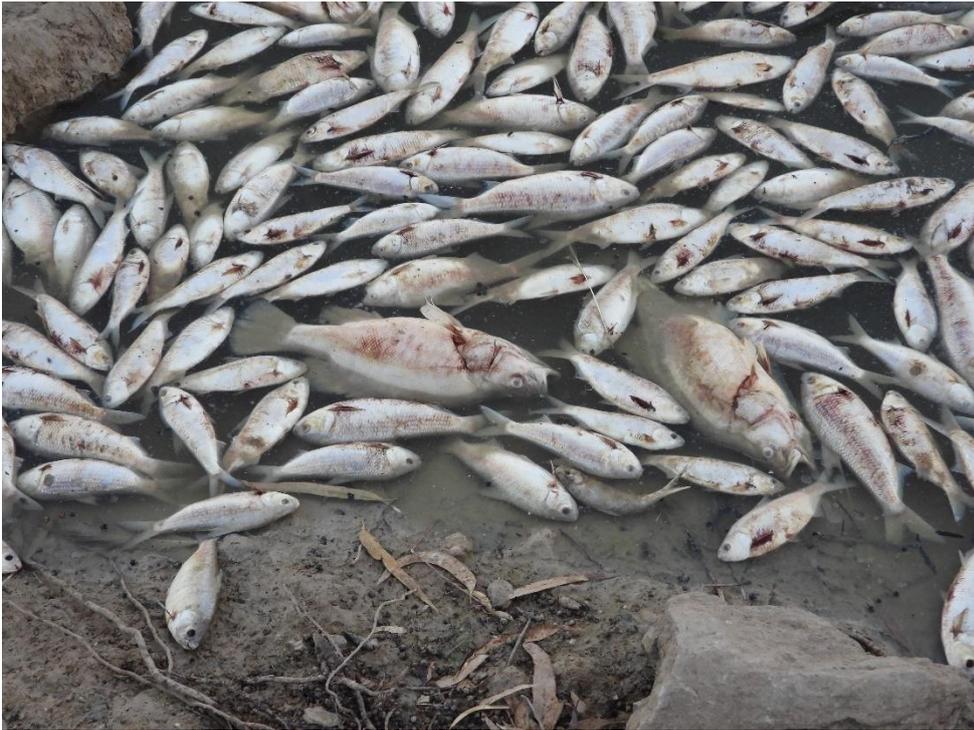
4248 6/3/23 Main Weir - dead fish

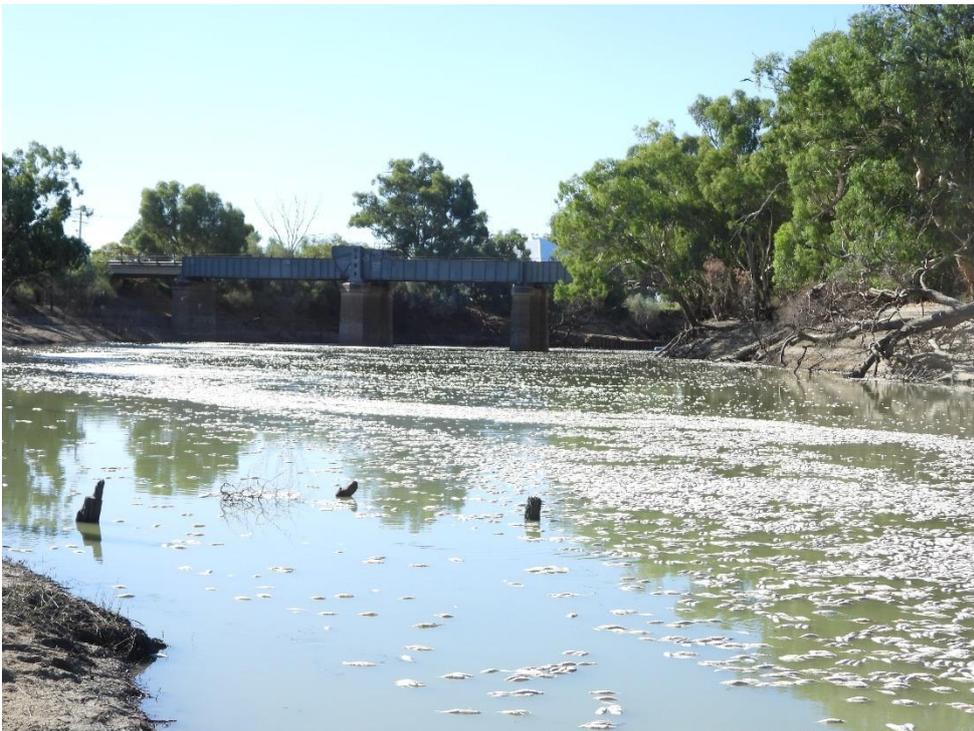
4261 17/3/23 Railway Bridge downstream. Fish being washed down river. Note no birds feeding. Not what was expected by people in the town

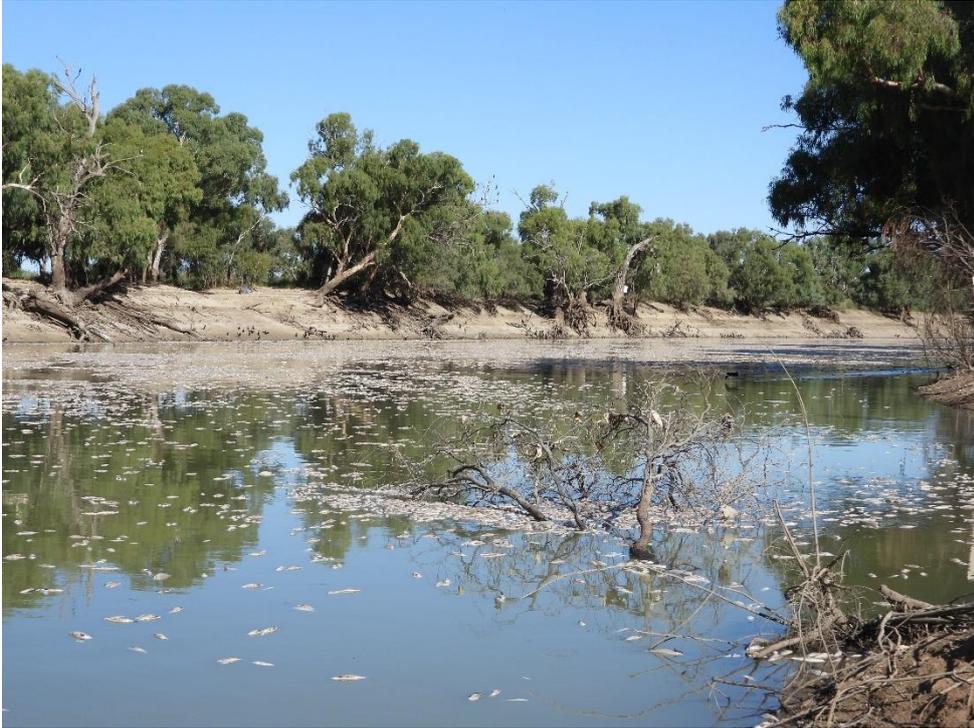
4265 17/3/23 Railway Bridge downstream. Fish being washed down river. Note no birds feeding.

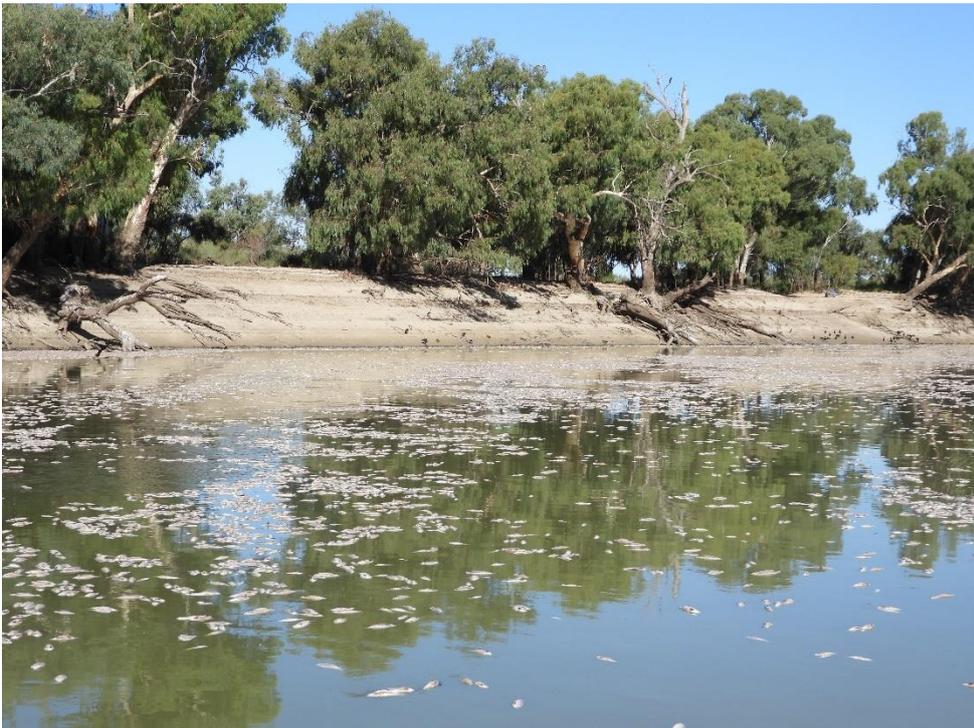
4268 17/3/23 Railway Bridge downstream. Fish being washed down river. Note no birds feeding.

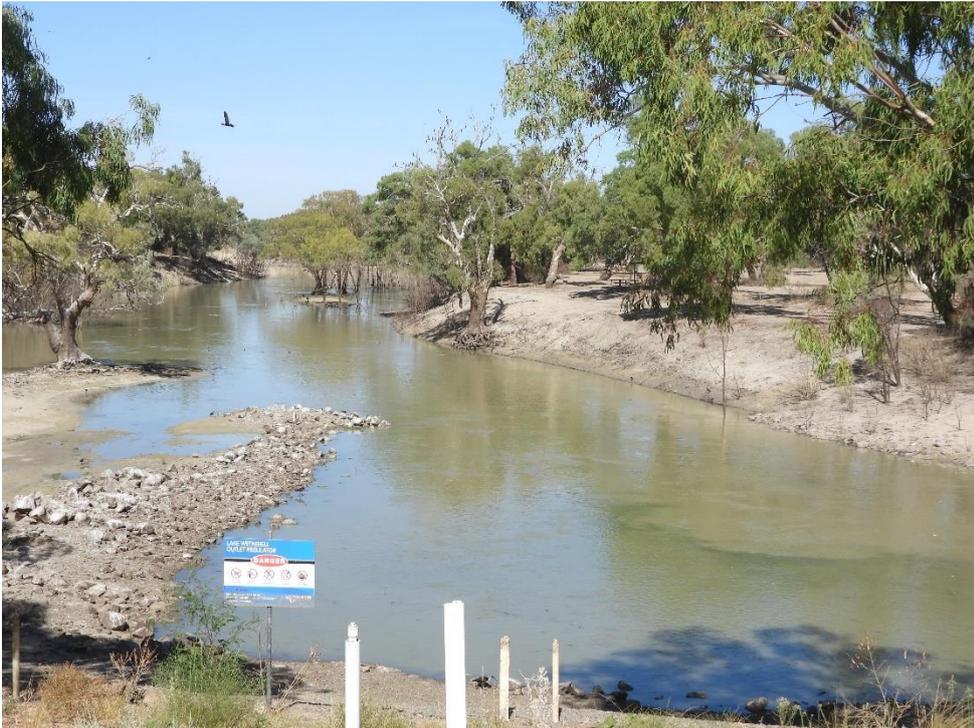
4276 18/3/23 Wetherell outlet regulator (No 8 on map) Note stain still in water being released into the river. This is most likely leakage from the regulator and illustrates the extent of the blackwater in the lake.

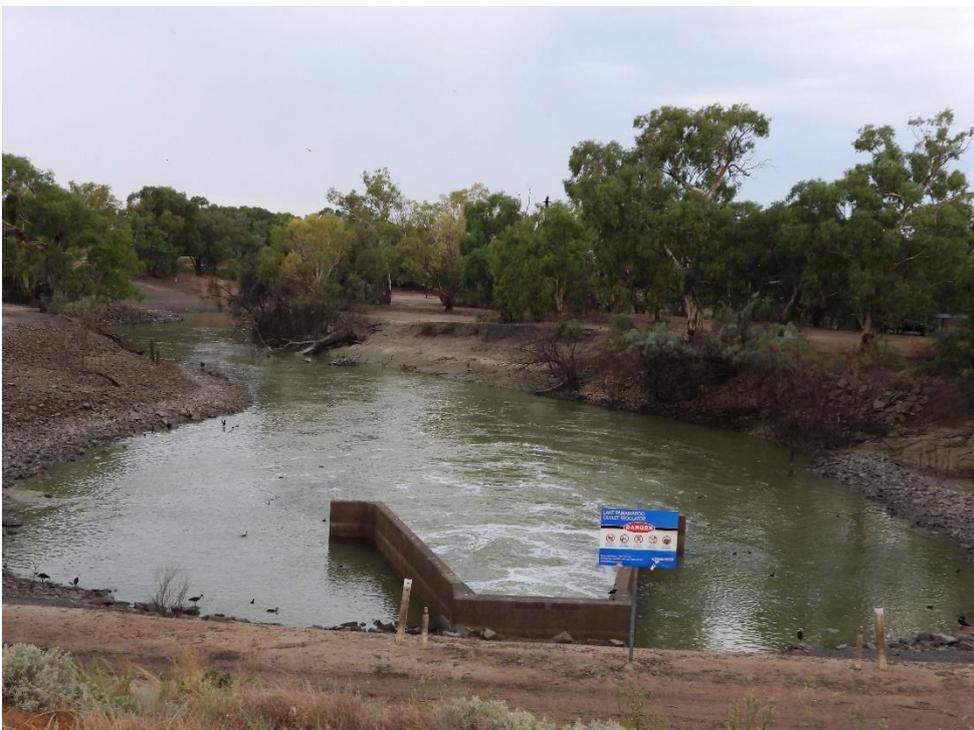
4452 21/3/23 Pamamaroo regulator (No 6 on map) from Pamamaroo into the river. Note darkness of water.

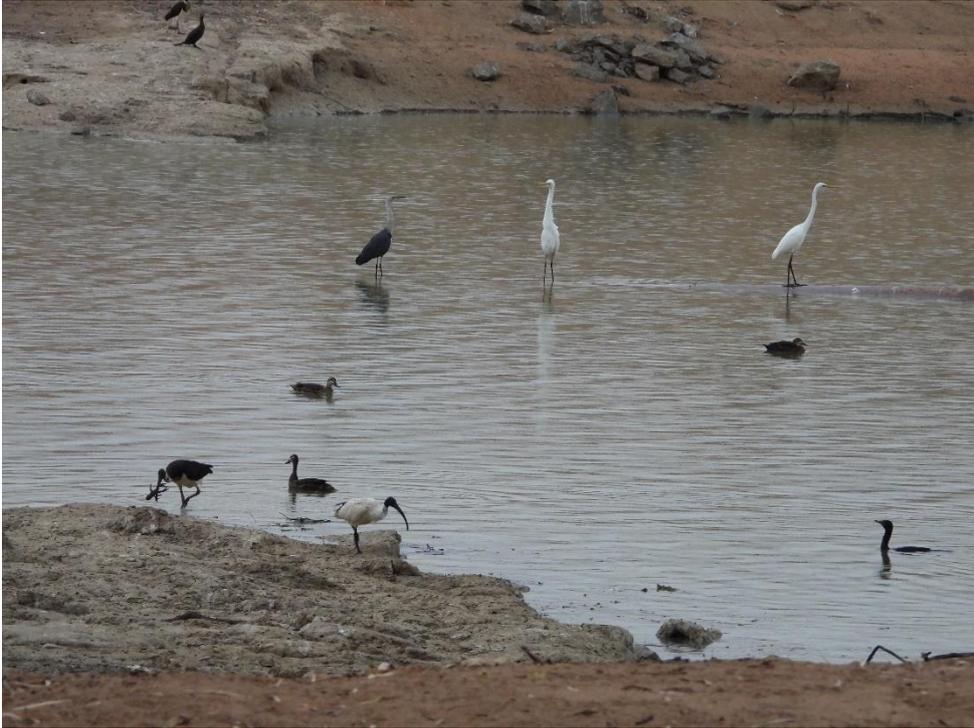
4475 21/3/23 Pamamaroo outlet. Note bird taking yabby. Note colour of water. Yabbies still trying to escape poor water.

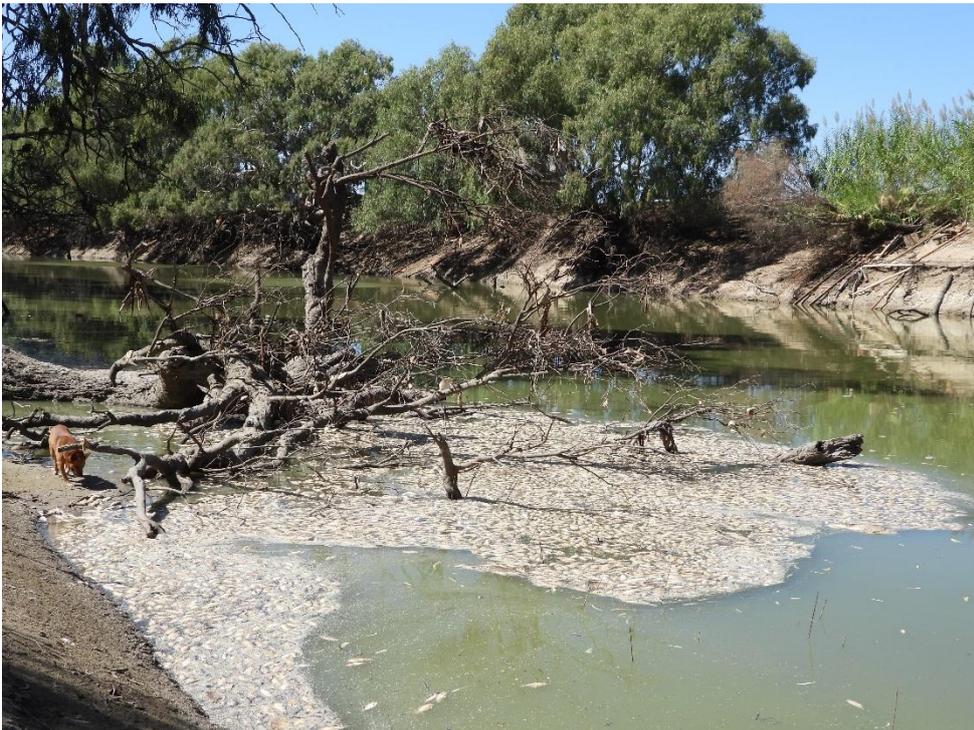
4527 23/3/23 Darling River Menindee, near town. Note slime build up from putrefying fish. Stench almost impossible to bear.

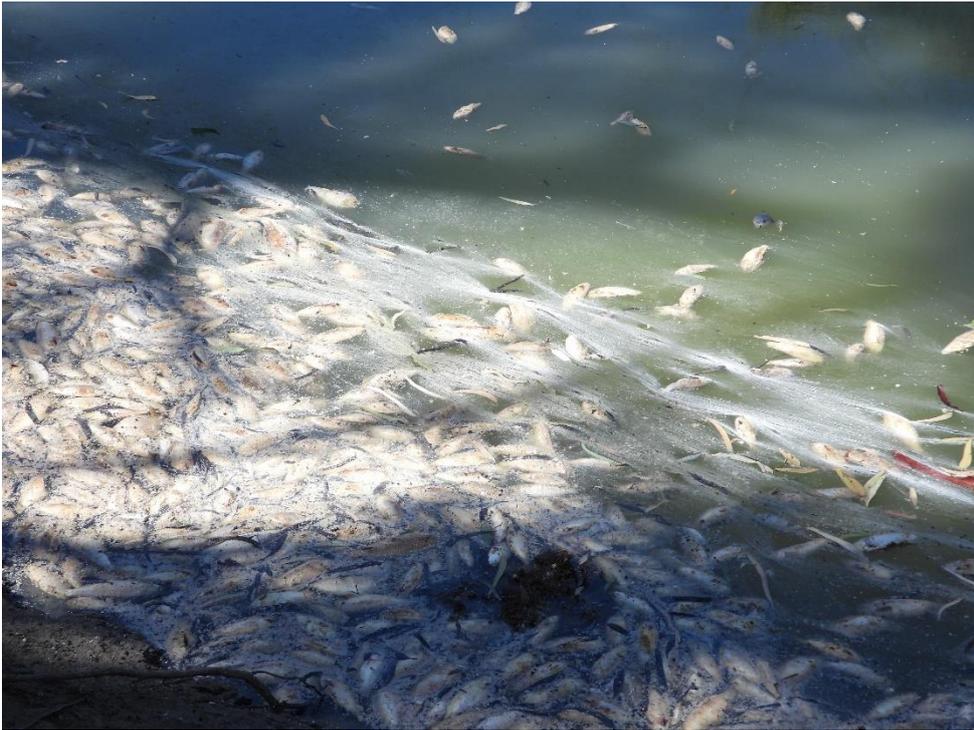
4543 23/3/23 Darling River Menindee, near town. Note slime build up from putrefying fish.

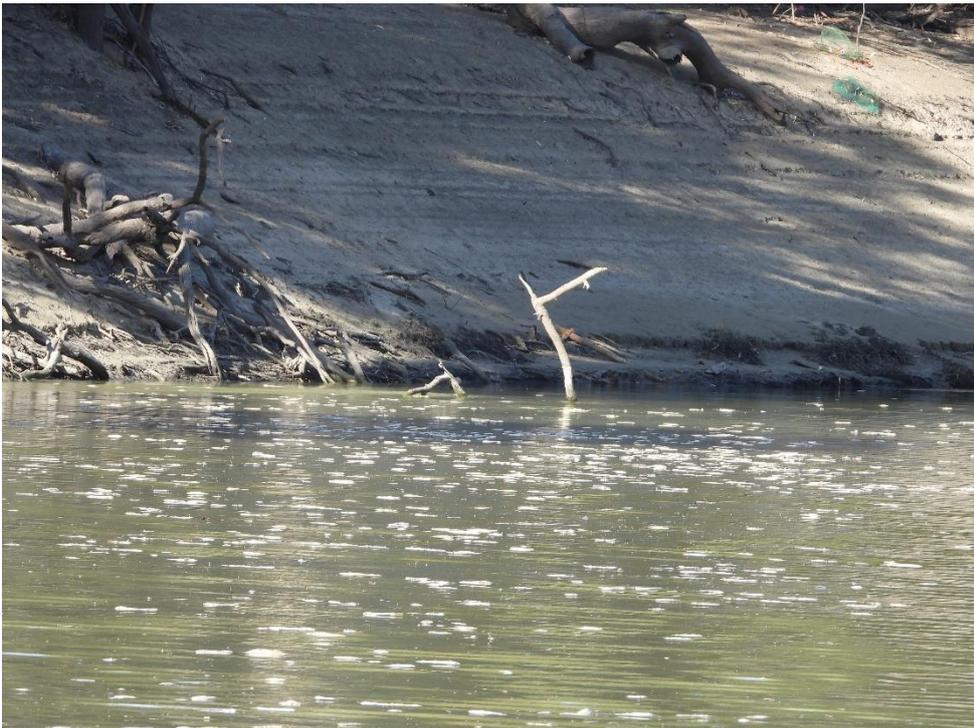
5525 12/4/23 Darling River below Menindee close to Menindee outlet regulator (Number 3 on map). Fish are still in the area, were not washed downstream, so are all on the bottom of the river.

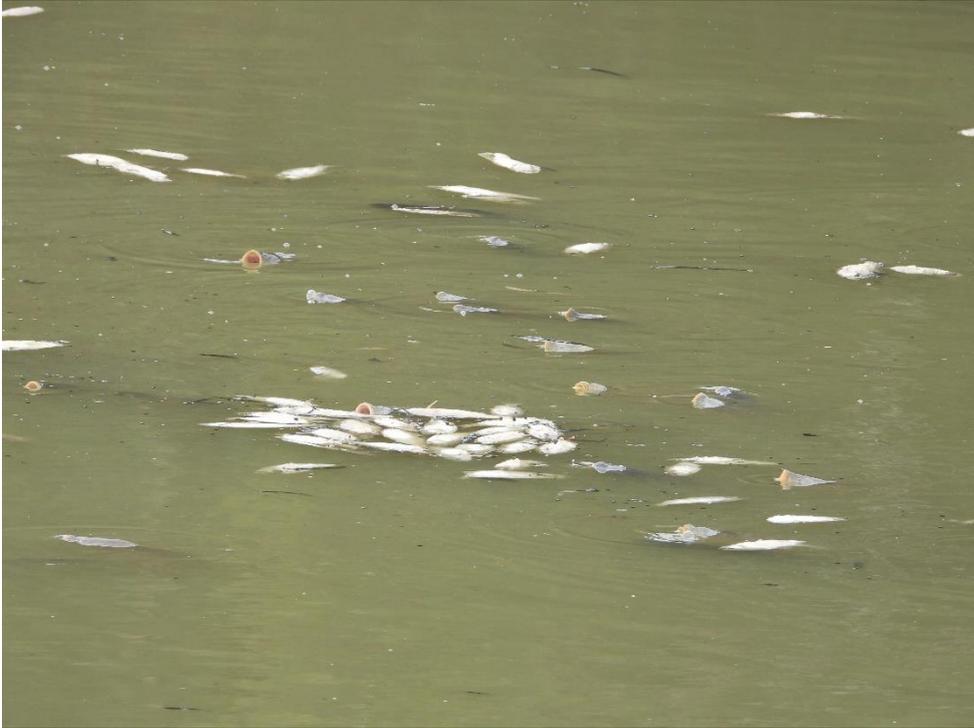
5535 13/4/23 Darling River below Menindee close to Menindee outlet regulator (Number 3 on map). Fish are still in the area, were not washed downstream, so are all on the bottom of the river.
