Re: Proximate cause of the fish deaths In Weir 32 weir pool (Menindee) in March 2023

Subject: A preliminary assessment the of the sequence of events that led to the massive fish kill in Weir 32 weir pool (Menindee) on 16 -17 March 2023

Proximate cause of the fish deaths

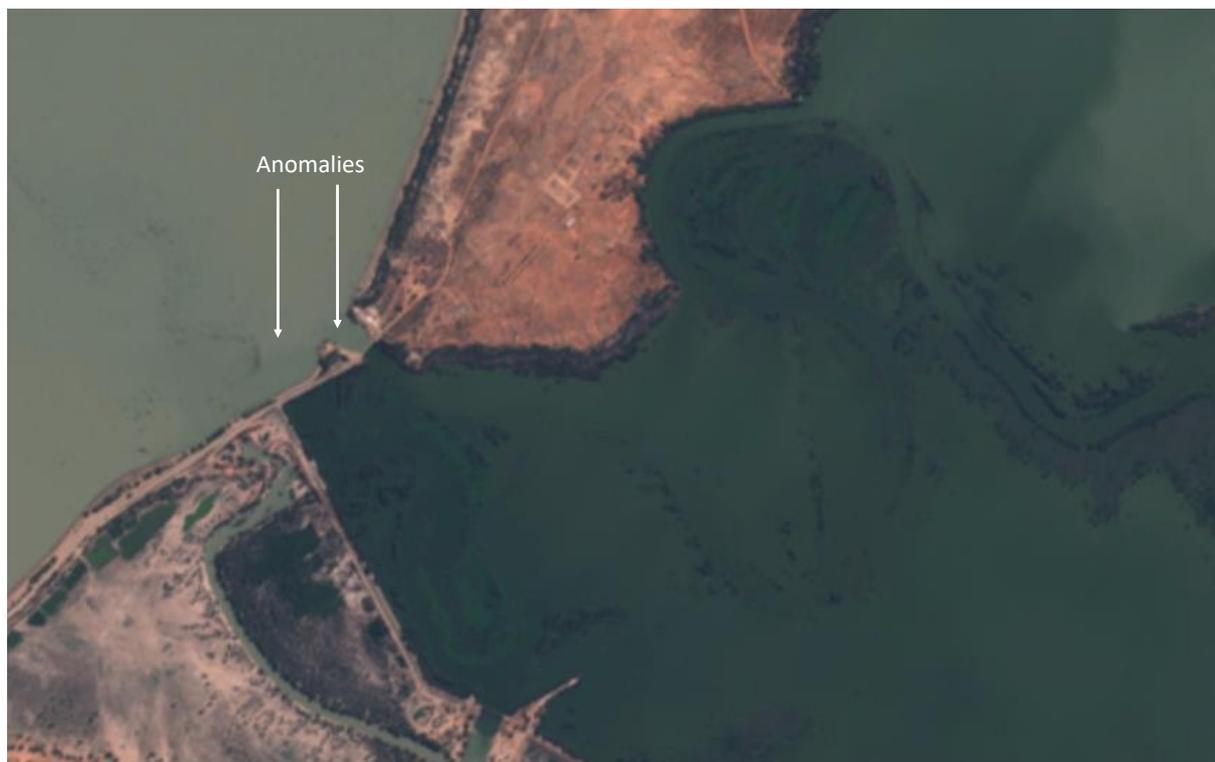
Figure 3: 'True Colour' Sentinel 2 image of Lake Pamamaroo (top left corner) and Lake Wetherell (bottom right corner) taken on March 14. Anomalies discussed in Williams and Schulz (2023) are indicated by arrows

Figure 3 Shows the 'true colour' sentinel 2 image of the area around the Lake Pamamaroo inlet and outlet on March 14 (Similar to Williams and Schulz Figure 9). The anomalies relied on by Williams and Schulz (2023) to indicate releases from Lake Wetherell to Lake Pamamaroo are highlighted. A few things to note. Firstly, the water in Lake Wetherell is green, more than black, indicating an algal bloom in Lake Wetherell. Secondly, the change in colour either side of the Lake Pamamaroo inlet is quite dramatic indicating little or no mixing has occurred (discussed in further detail below).

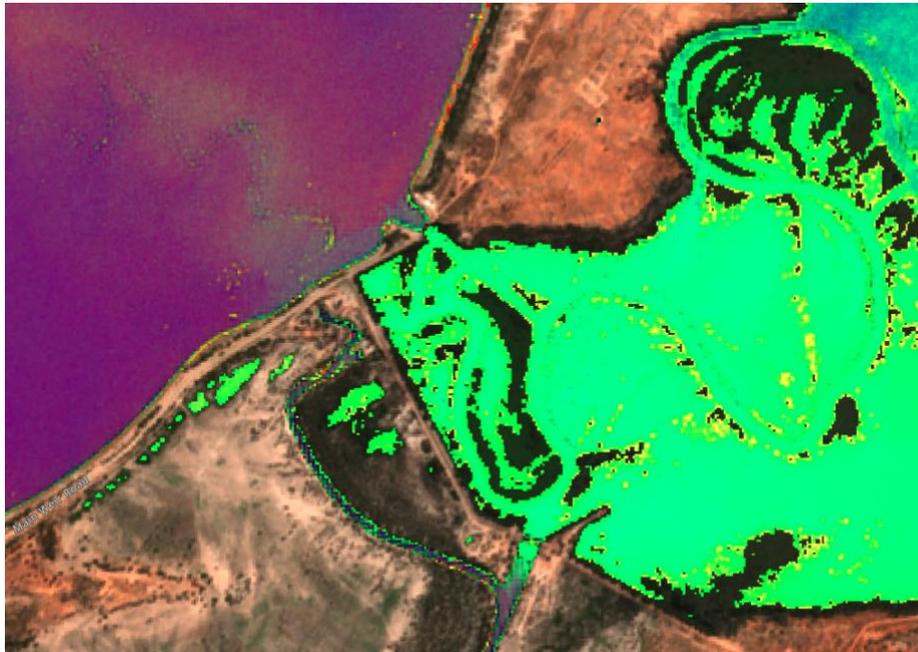
Figure 4: False colour Sentinel 2 satellite image of the same region as Figure 3, taken on March 14 and processed with the APA script. Green and yellow represent levels of high algal density. Purple is high concentrations of suspended sediments

A similar image, although this time processed with the APA script, which highlights algal biomass, suggests that if there were flows coming from lake Wetherell they would be trivial, consist with leakage (Figure 4). Inflows from Lake Wetherell (high in algal density) to Lake Pamamaroo (low in algal density) would be obvious from the false colour satellite images. To make this point clearer, Figure 5 shows the same location as Figure 4, but taken on March 22 when the flow into Lake Pamamaroo from Lake Wetherell was 1000 ML/day.
