2023 Menindee Mass Fish Kill: How it happened.

A desktop investigation unravelling the operational decisions that preceded the death of 20 million fish

by Megan Williams and Dan Schulz

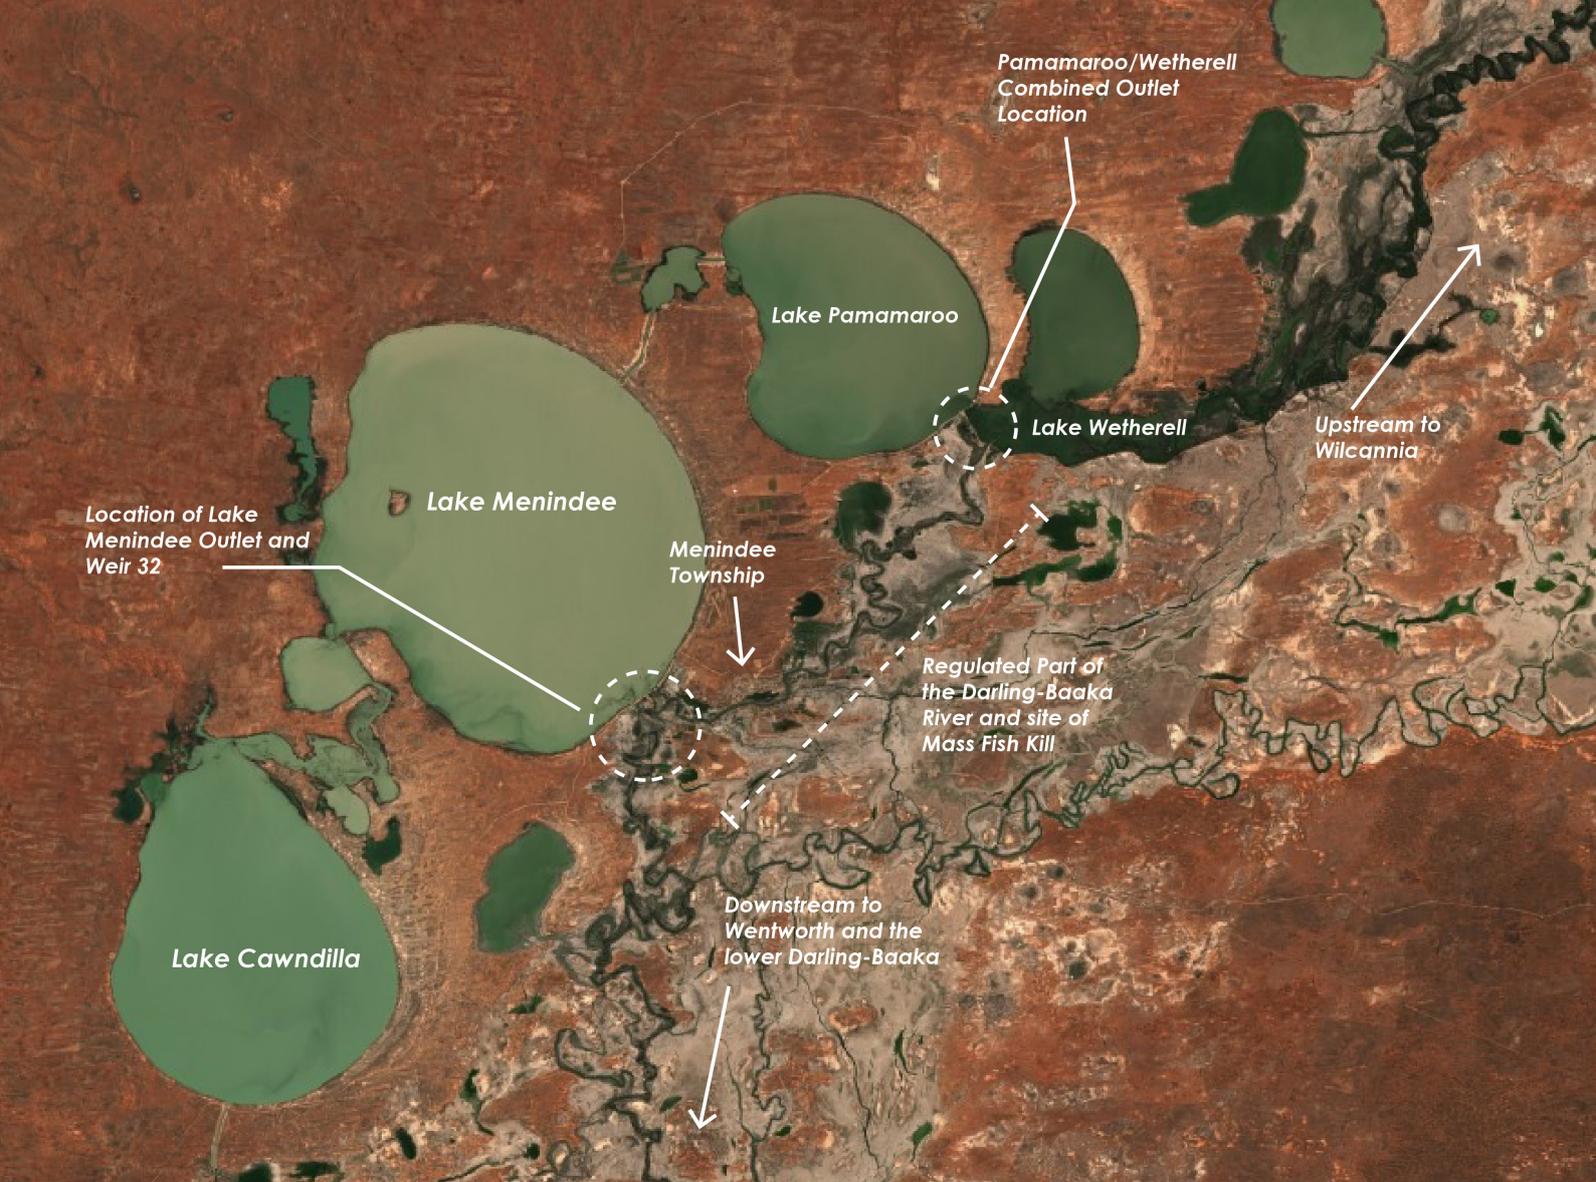
Figure 1 - Satellite image of Menindee Lakes showing outlet locations

The floods of 2023 resulted in an enormous volume of blackwater entering the Menindee Lakes System from the Barwon-Darling (Figure 1). As floodwaters receded from the floodplains a large volume of floodplain nutrients, organic matter, and sediments accumulated in the river channel. This caused Lake Wetherell to become a storage of deoxygenated blackwater. These conditions presented challenges to river operators.

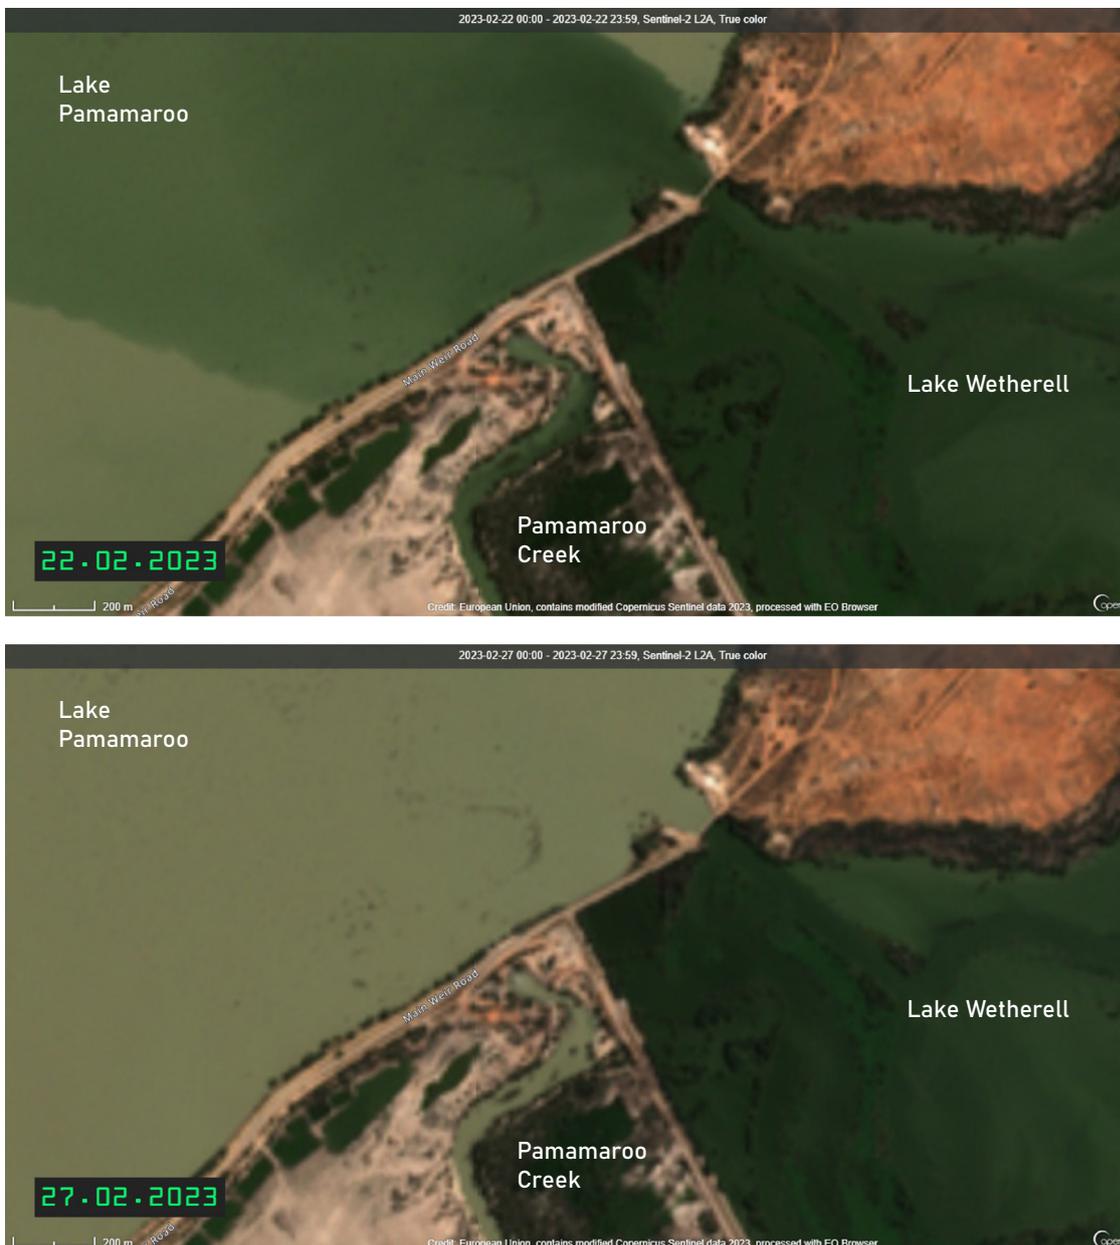
Figure 7 - Satellite images of Pamamaroo inlet on February 22nd and 27th, showing the dramatic reduction of releases from Lake Wetherell, improving the dissolved oxygen levels in the regulated section of the Darling-Baaka River

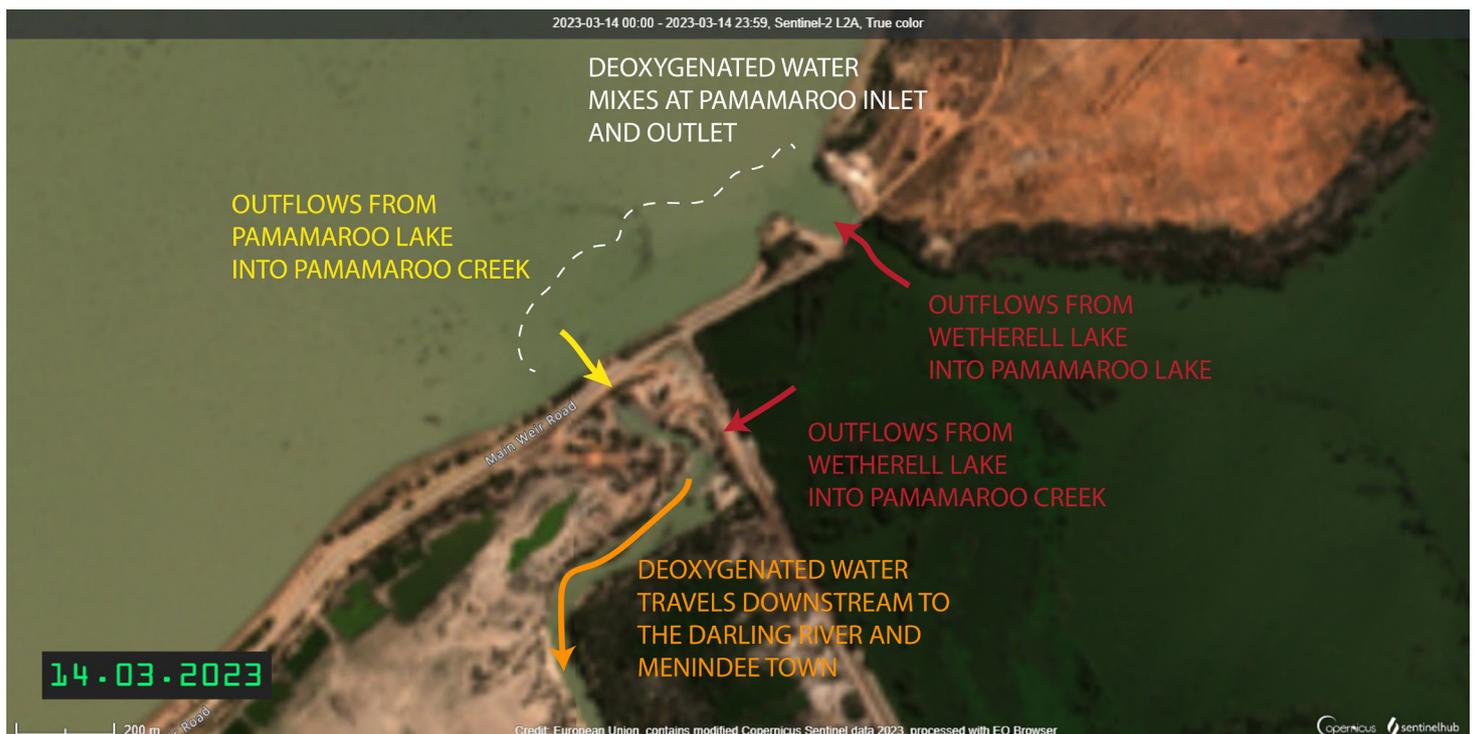
Figure 9 - Diagram of blackwater being discharged into the regulated section of the Darling-Baaka River on March 14th

Satellite imagery on March 14th, confirms the regulator between Lake Wetherell and Lake Pamamaroo had been opened (Figures 10 & 11). A comparison of satellite imagery from March 4th and March 14th shows a plume of blackwater entering Lake Pamamaroo from Lake Wetherell, and travelling to the Pamamaroo outlet where it was discharged into Pamamaroo Creek (Figure 9).

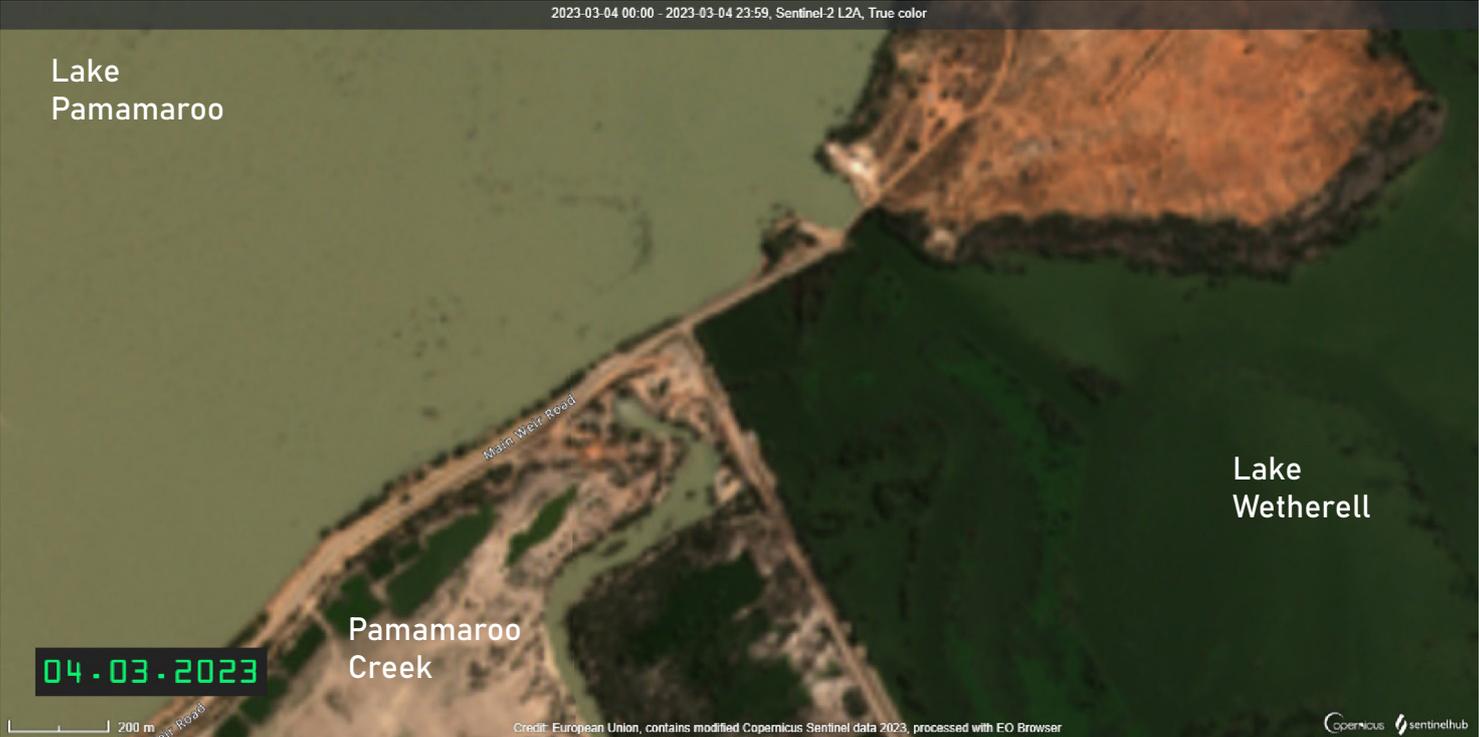
Figure 10 - A comparison of satellite imagery from March 4th and March 14th shows a discolouration around the Pamamaroo Inlet

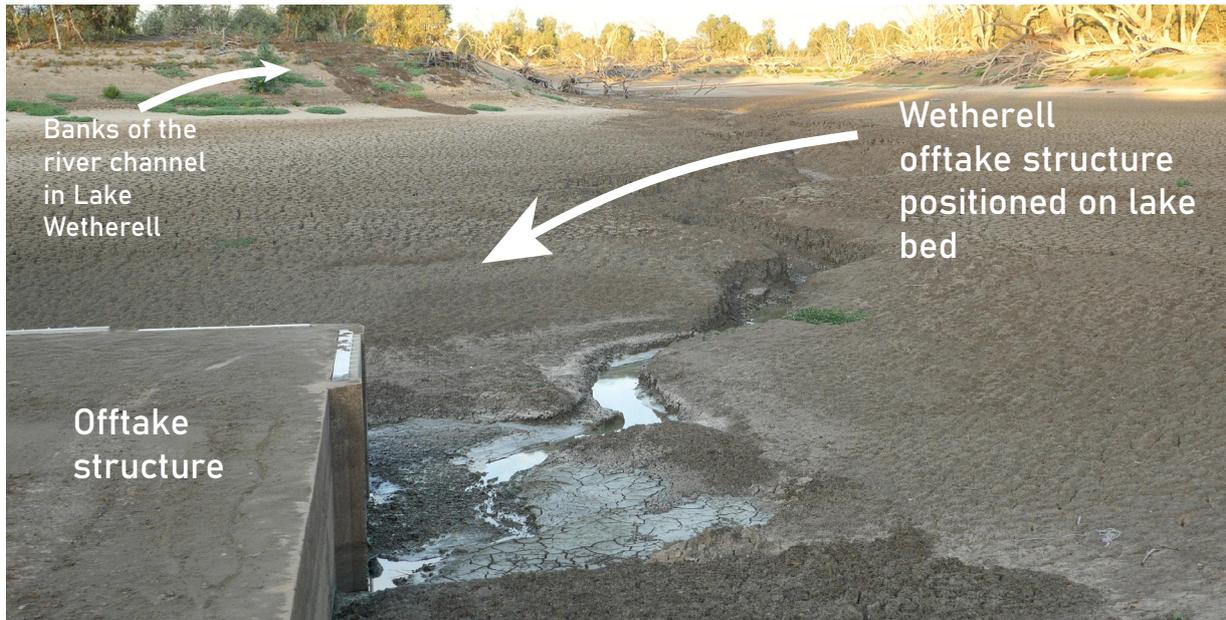
Figure 15 - Lake Wetherell pictured March 2020. Offtake structure draws water from the bottom of the lake bed. Photo by Dan Schulz on March 11, 2020

As observed by Geoff Looney, controlled releases into Pamamaroo Creek via the Wetherell outlet are of much poorer quality than the releases from Lake Pamamaroo. The discharge via the Wetherell outlet is taken from the lowest strata of Lake Wetherell, as the offtake structure is located on the lakebed (Figure 15).

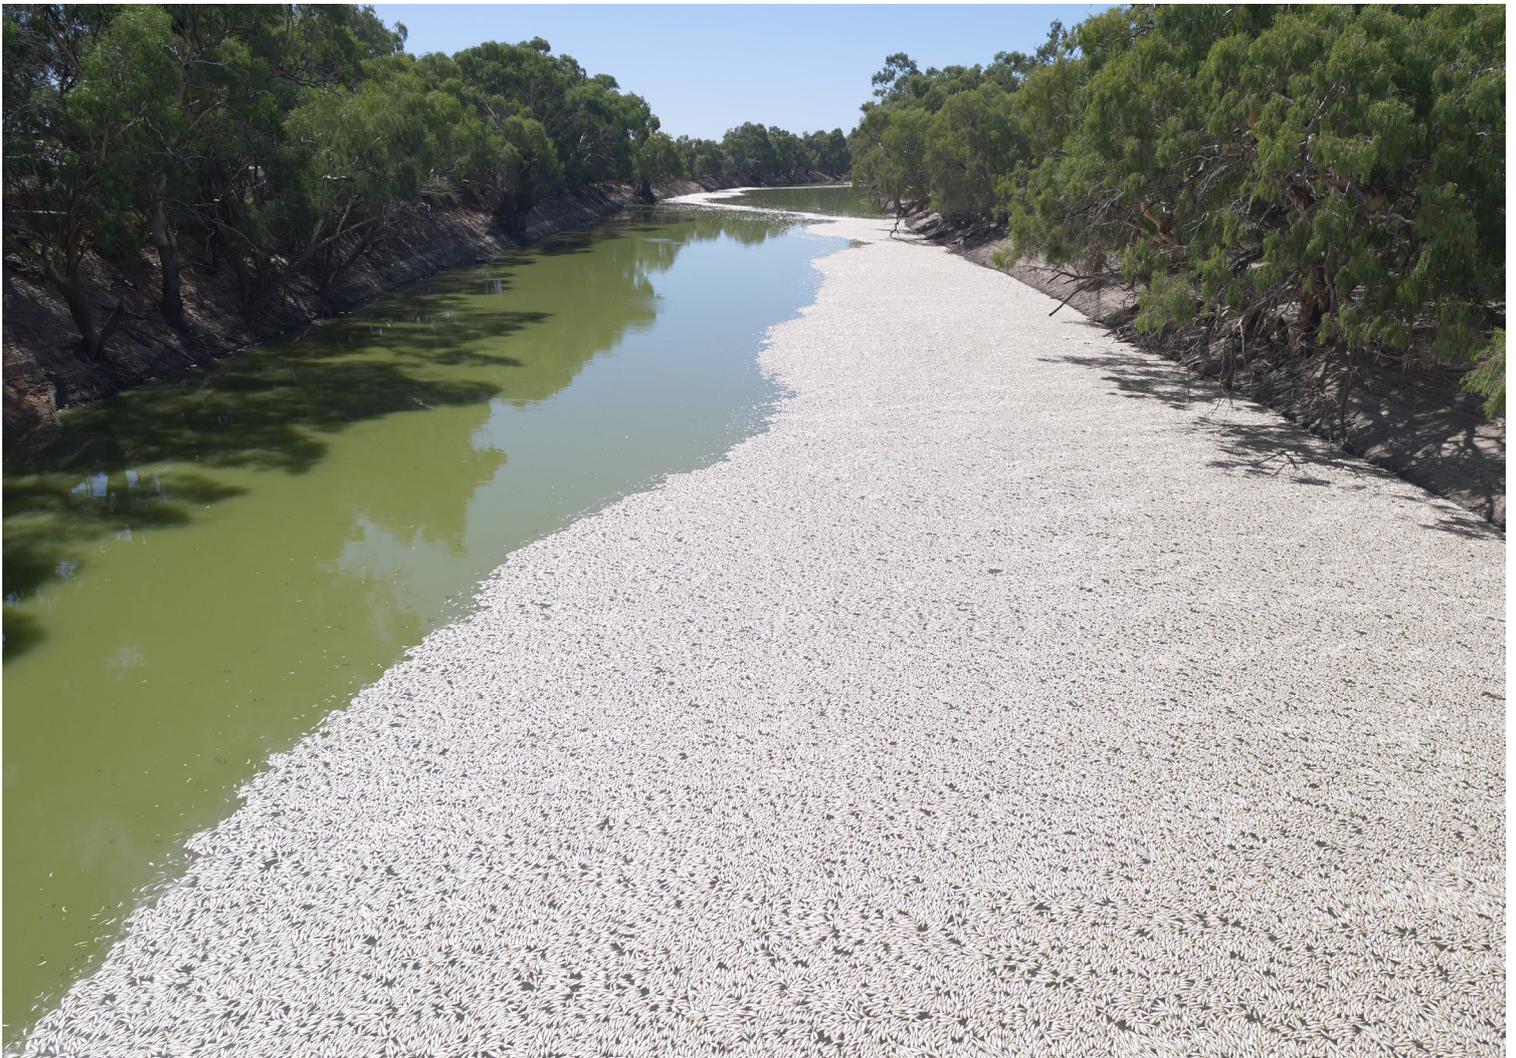
Figure 18 - Stream of dead fish observable from the road bridge in Menindee Town. Photo taken by Daniel Schulz on March 18th

The mass fish kill event peaked during March 17th & 18th (Figure 18 & 19), and media reports typically state 20 million fish perished in this event, although exact numbers are unknown.

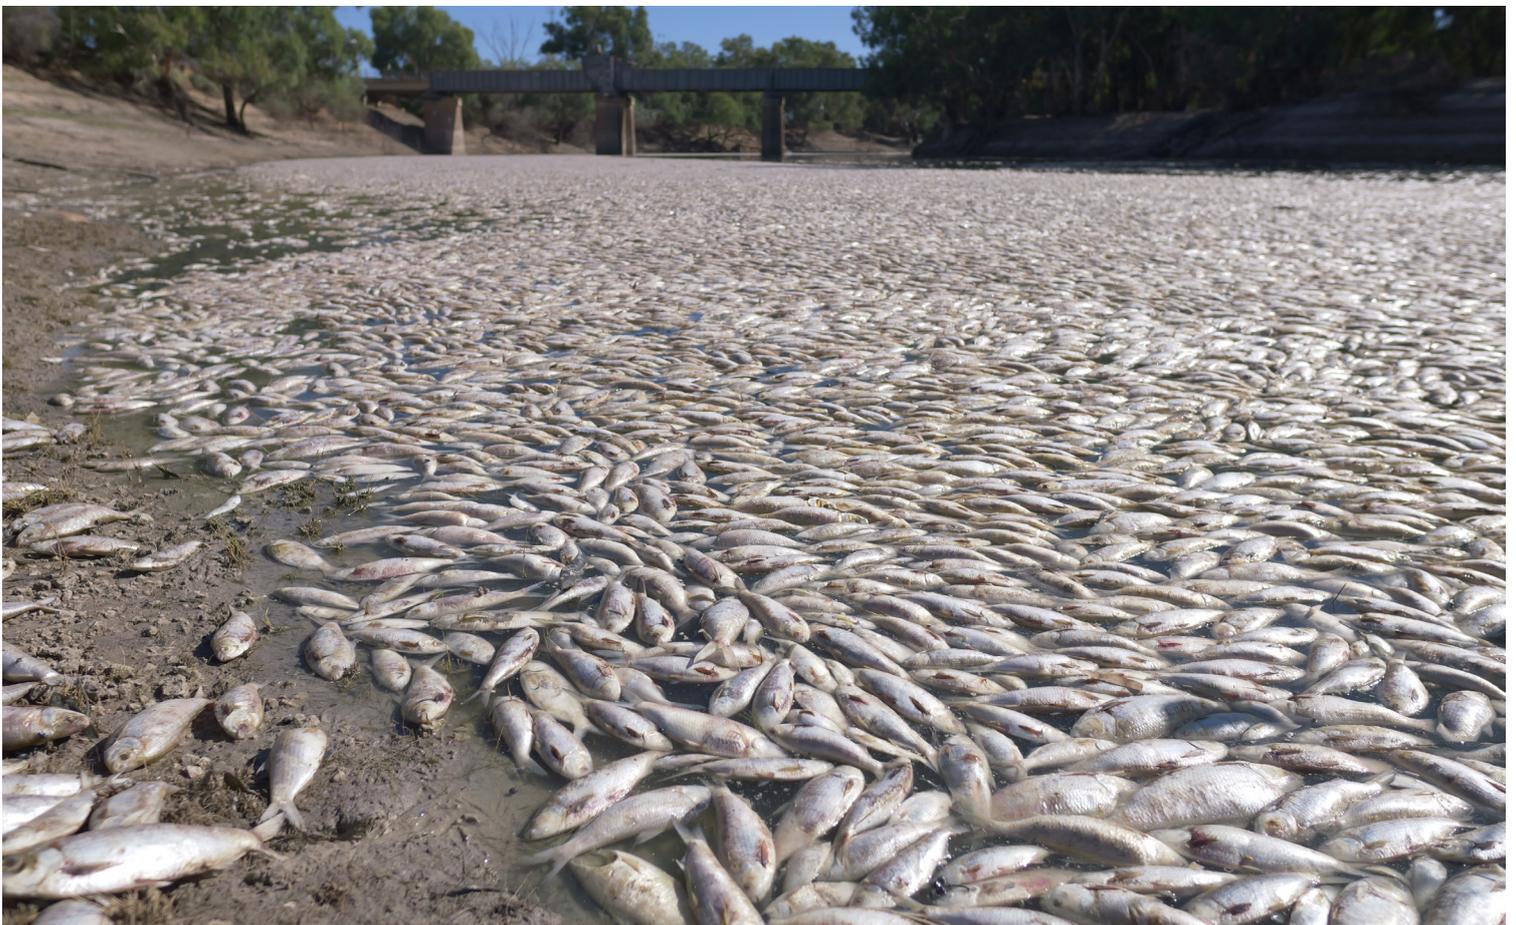
Figure 19 - Stream of dead fish observable from the railway bridge in Menindee Town. Photo taken by Daniel Schulz on March 18th

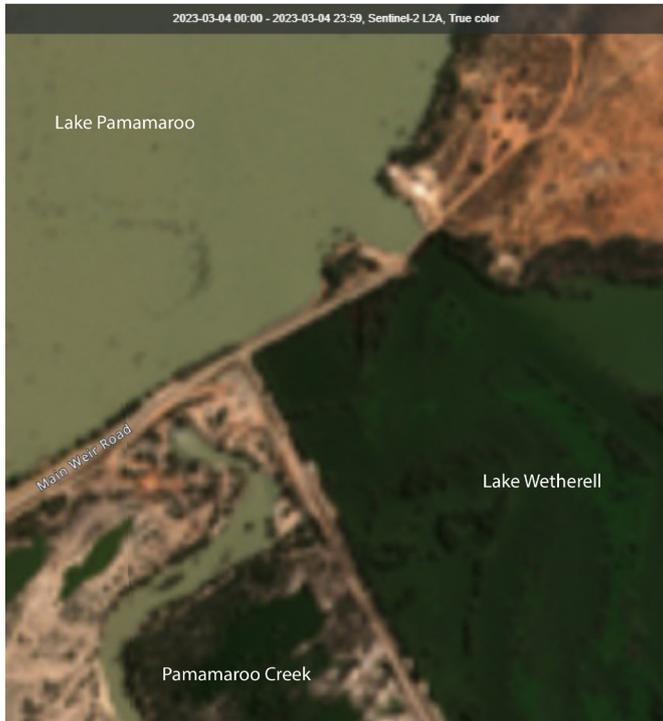
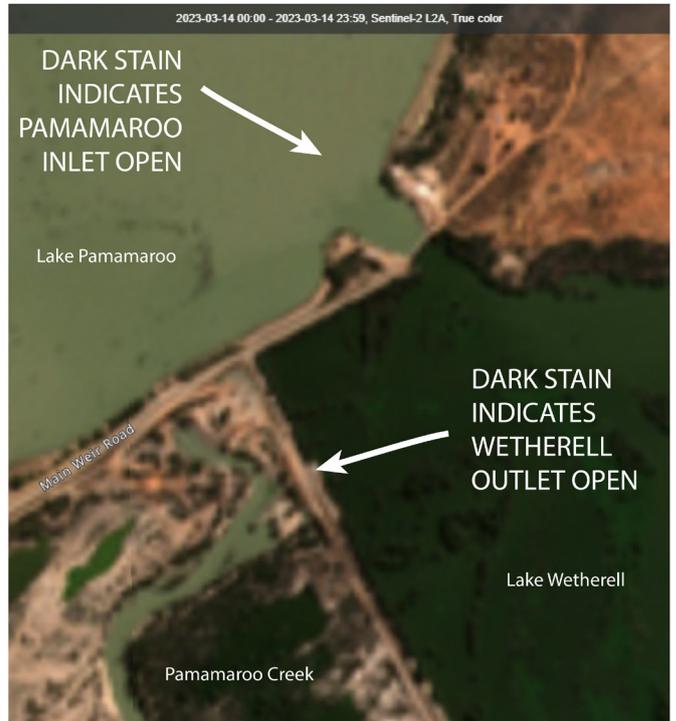
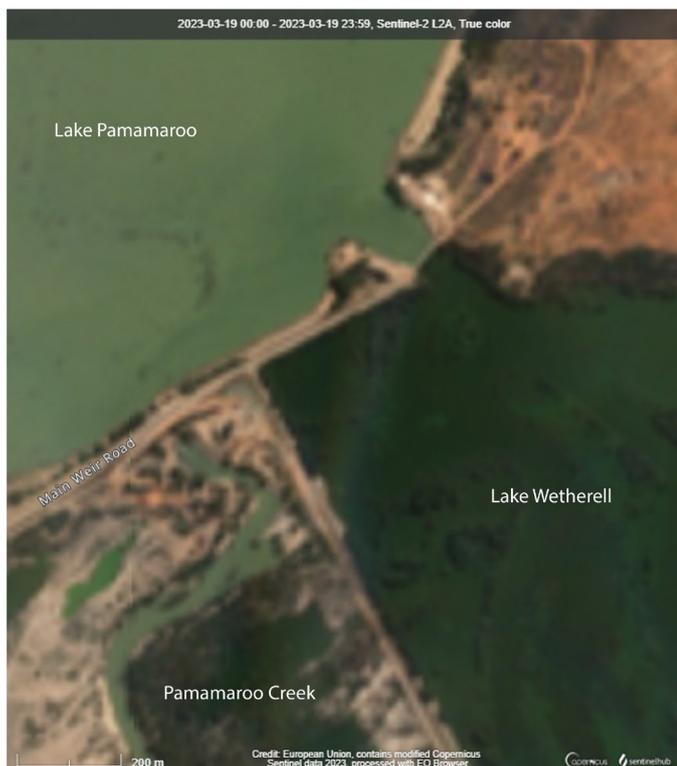
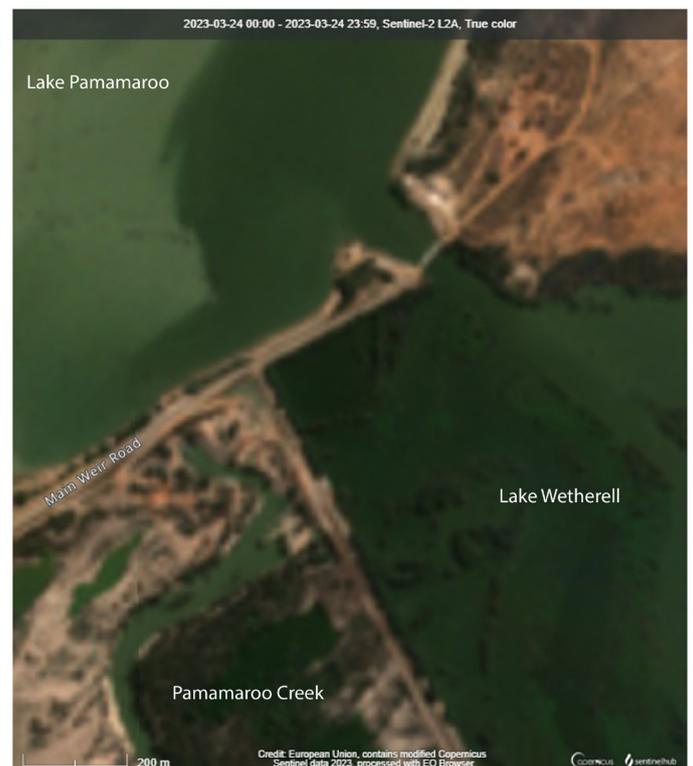
March 4th, 2023 - WETHERELL OUTLETS CLOSED - NO BLACKWATER DISCHARGE

March 14th, 2023 - WETHERELL OUTLETS OPENED - BLACKWATER DISCHARGES BEGIN

March 19th, 2023 - WETHERELL OUTLETS OPENED - BLACKWATER DISCHARGES CONTINUE

March 24th - WETHERELL OUTLETS OPENED FURTHER - BLACKWATER DISCHARGES INCREASED

Figure 21 - Sequence of satellite images from March 4th - March 24th, showing blackwater travelling into the regulated section of the Darling-baaka River

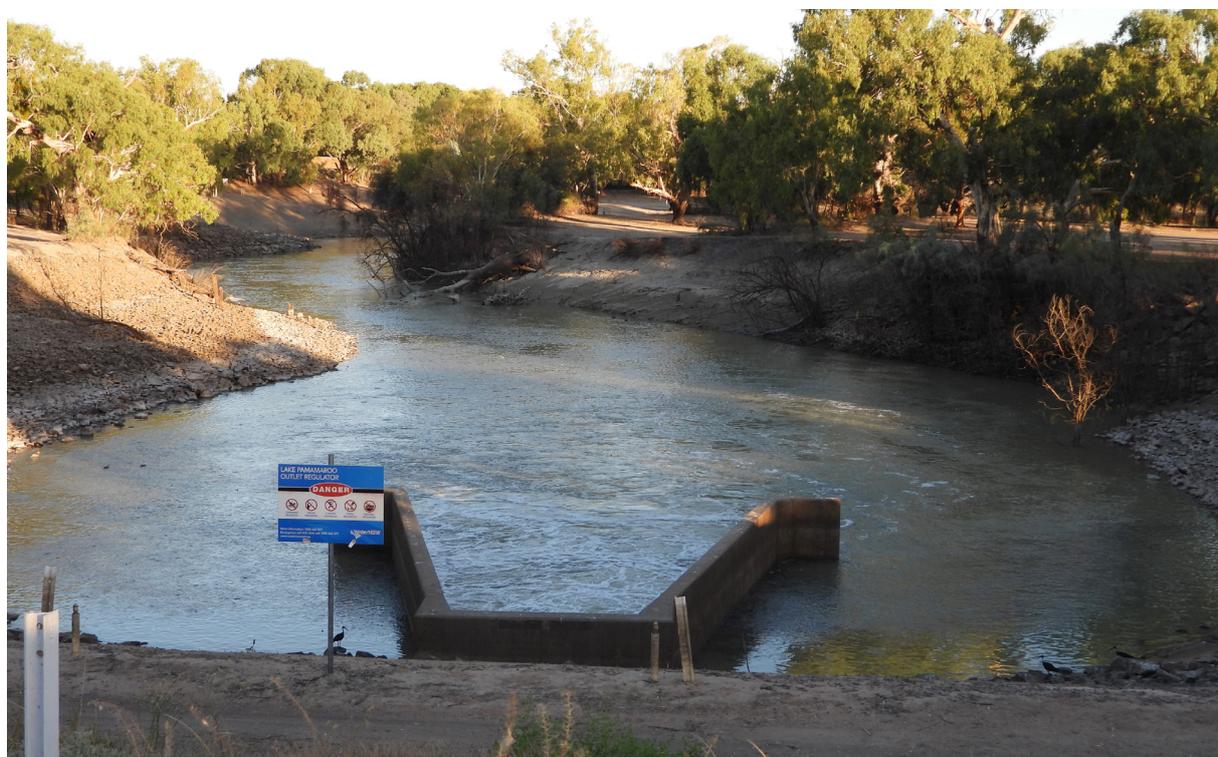
A photograph by Geoff Looney on March 16th, the day the March mass fish deaths were first observed, shows the Pamamaroo outlet was open (Figure 26). Satellite imagery of blackwater entering Pamamaroo Lake can be observed on March 14th.

Figure 26 - Menindee NSW Outback Photography by Geoff Looney - Documentation of releases from Lake Pamamaroo into Pamamaroo Creek - Photo taken 16.03.23

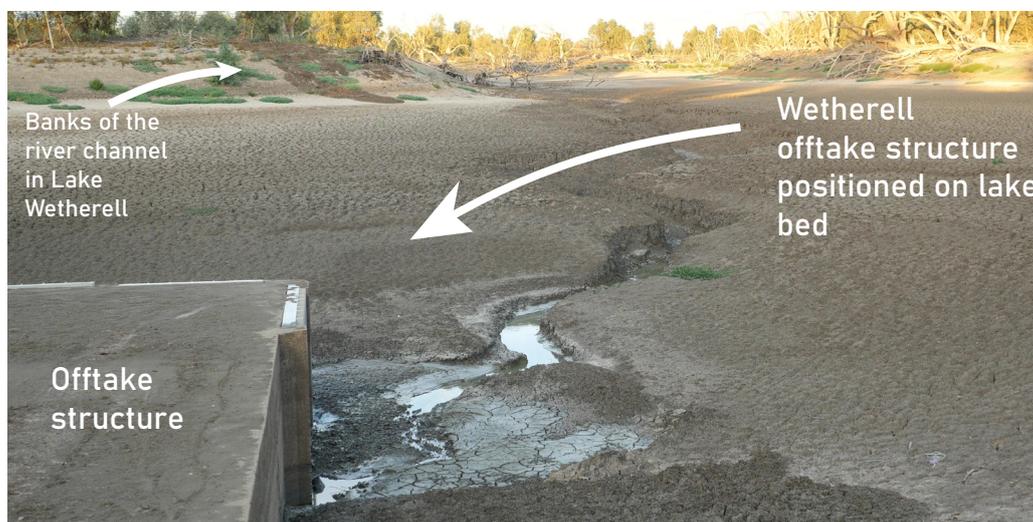
The Wetherell outlet that releases flows into Pamamaroo Creek receives its water intake from the lowest strata of Lake Wetherell, as the offtake structure is located on the lake bed. In a severe blackwater event such as what had occurred in Lake Wetherell in 2023, anoxic blackwater had likely accumulated at the bottom most layer of the reservoir (Figure 15). In this case, the Wetherell outlet is the worst possible choice of releases for dissolved oxygen outcomes in the regulated section of the Darling-Baaka River.

Lake Wetherell pictured 11 March 2020. Offtake structure draws water from the bottom of the lake bed. Photo by Dan Schulz

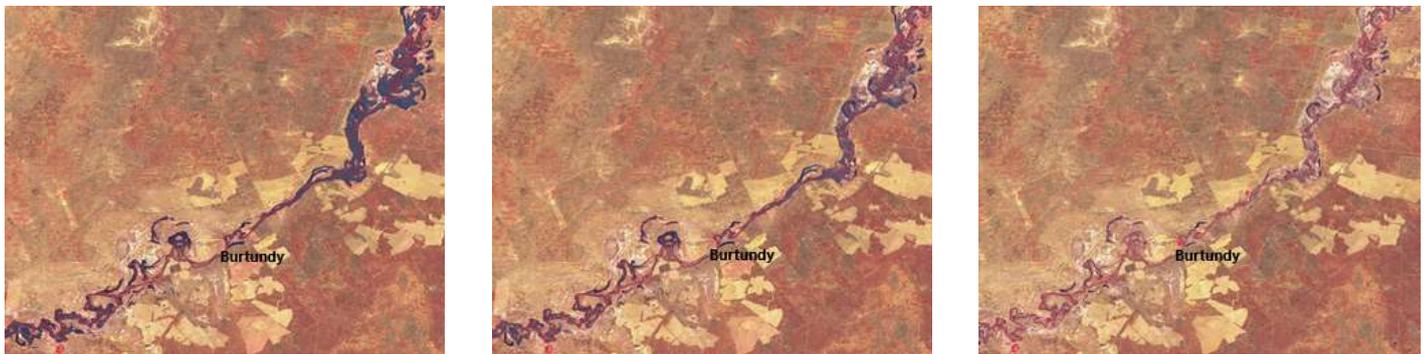
Figure 3: Series of satellite derived Sentinel colour infrared images of the lower Darling River at Burtundy. Images 27 February (left), 4 March (middle) and 14 March (right)

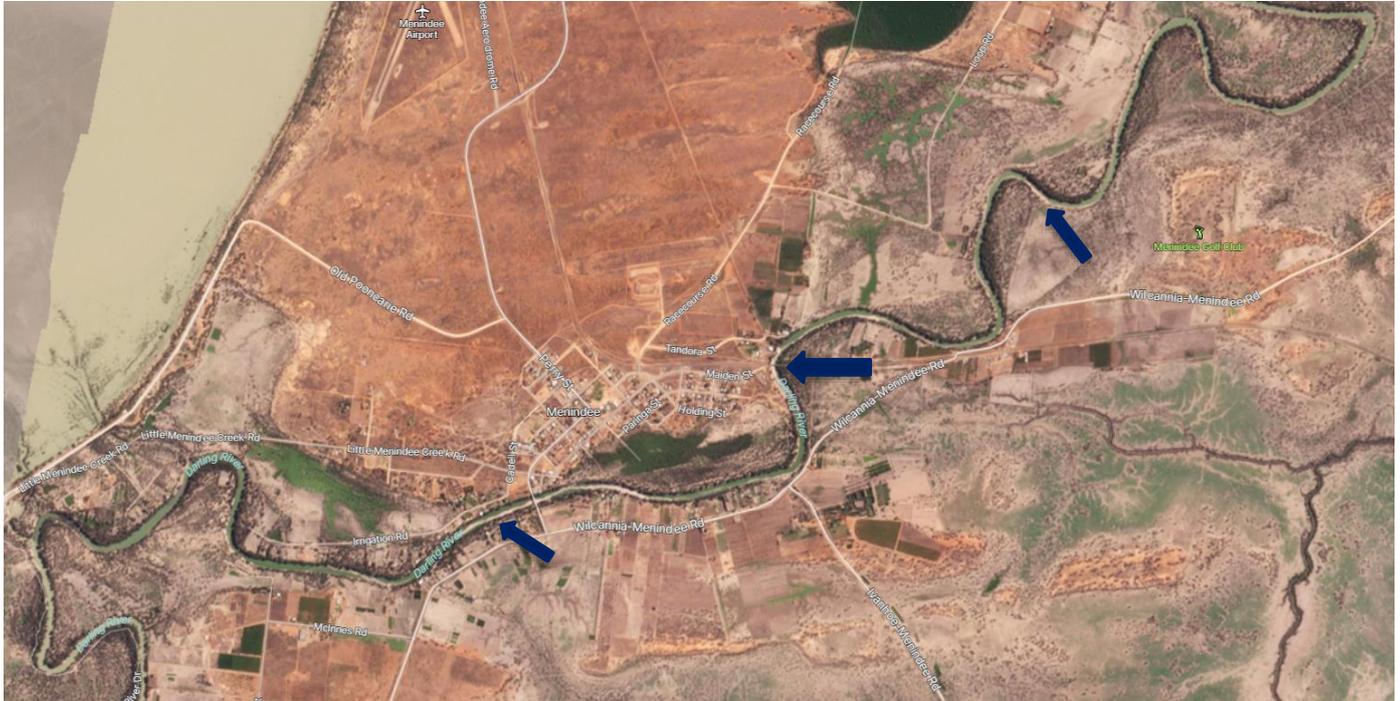
Figure 1: Planet satellite image from 17 March 2023 showing dead fish accumulating along the banks of the Darling River at Menindee

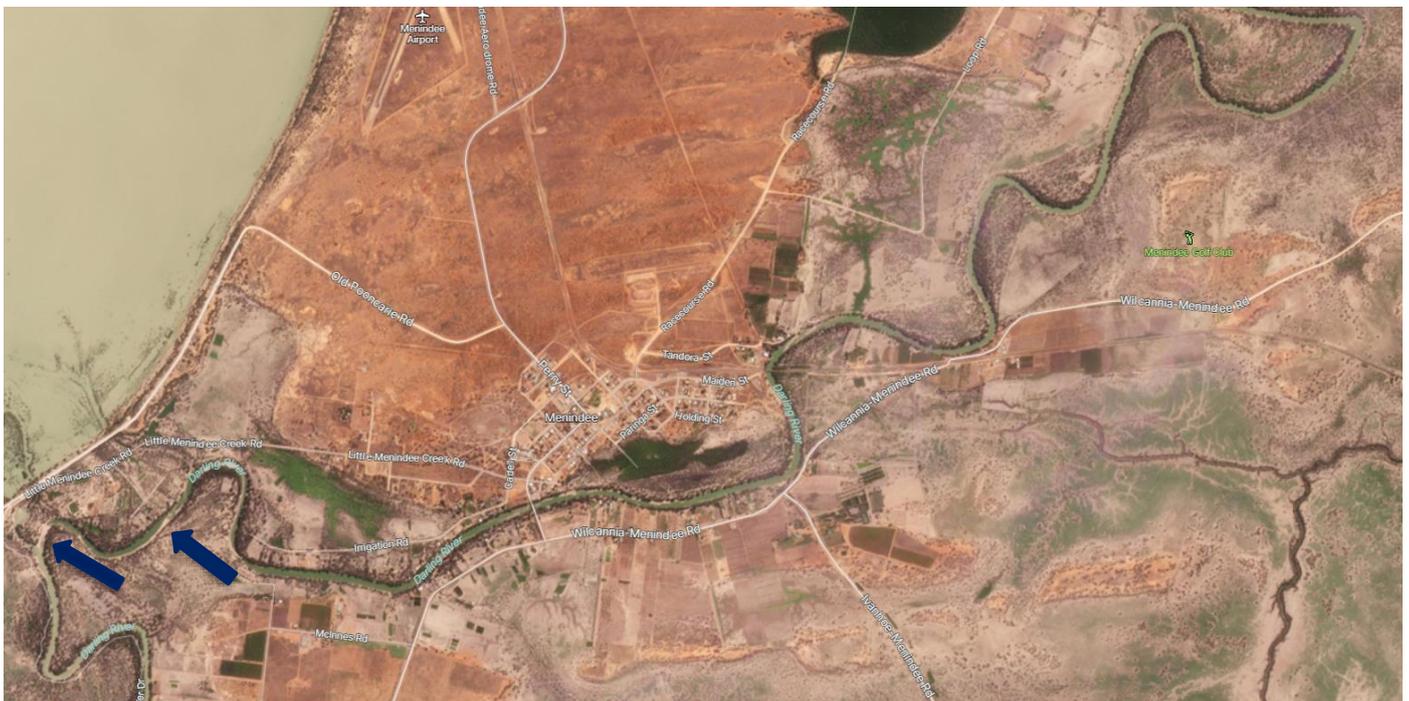
Figure 2: Planet satellite image from 19 March 2023 showing an accumulation of dead fish at the junction of the Darling River and Menindee Creek

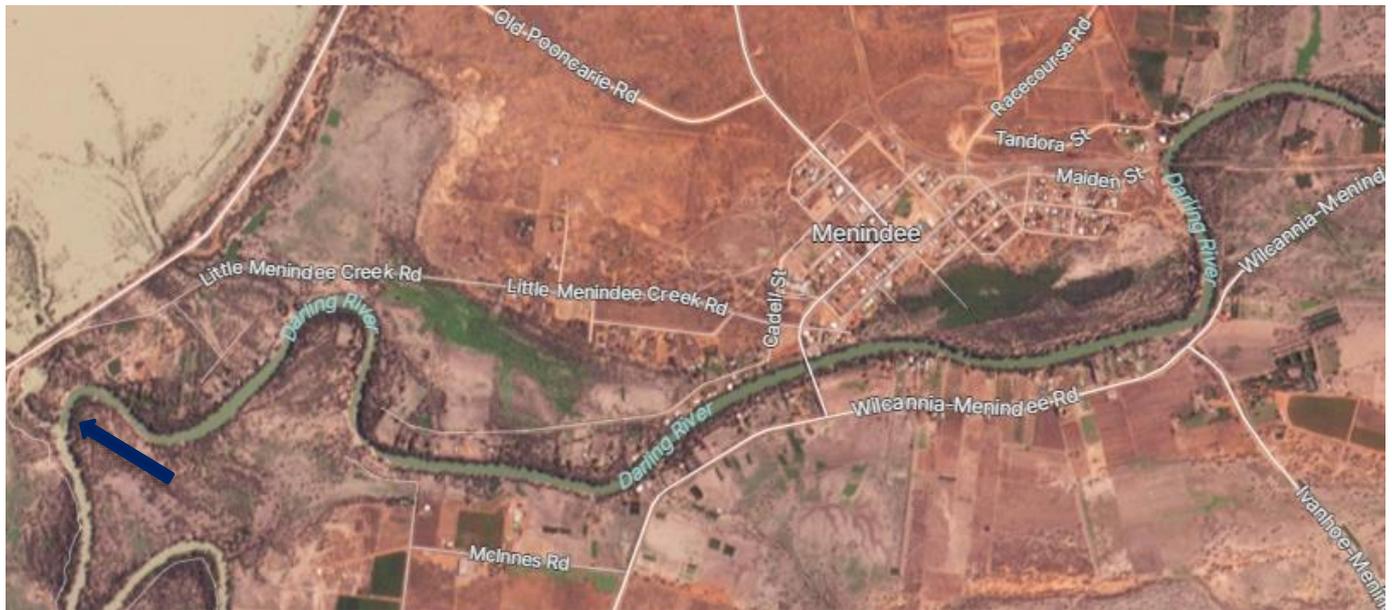
Figure 3: Planet satellite image from 21 March 2023 showing the accumulation of dead fish that was at the junction of the Darling River and Menindee Creek has been dispersed
